Docket No. 272 – Development and Management Plan Inspection

East Devon Substation Inspection

Date: March 30, 2007

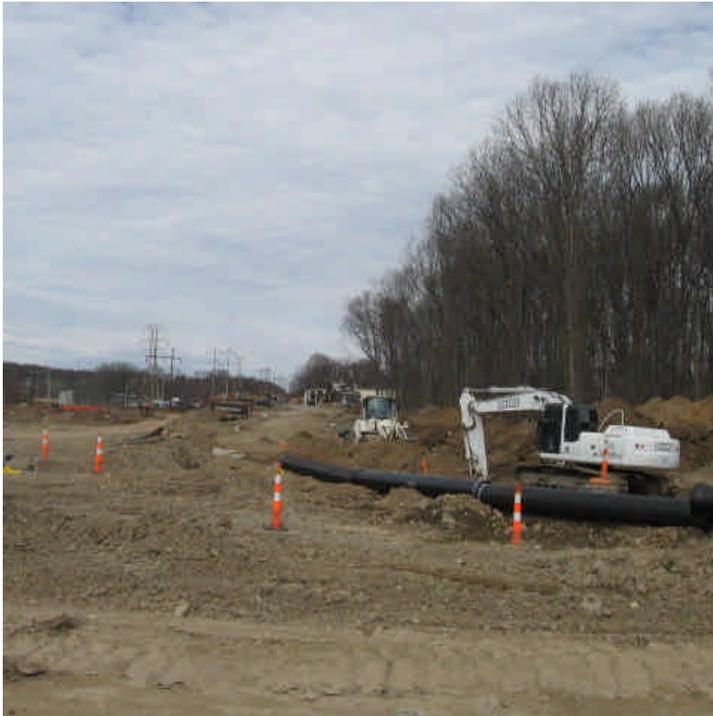
Work associated with the re-location of Shelland Street continues to the east of the Substation site.

Areas of Inspection	Observation	Recommended Action	Corrected Action
Access Roads and Adjacent Roadways	Work associated with the relocation of Shelland St continues to the east of the existing overhead ROW. Raised catch basins (CBs) are noted in the area but are non-operational at this time. 3/30/07	Continue to monitor and add controls as necessary. 3/30/07.	Not Applicable (NA)
	Access points are noted and roadways are being constructed in two locations off Plains Rd, and at the relocated Shelland St. 3/30/07	Continue to monitor for sediment tracking and construct stone access pads at the entrances to reduce tracking. 3/30/07	NA
	Sediment tracking was minimal on Plains Rd this week. The roadway appears to have been swept recently. 3/30/07	Continue to monitor for sediment tracking and sweep the roadway on a regular basis. 3/30/07	The roadway had been swept recently
	“Silt saks” (or similar) remain within the CBs along Plains Rd. in the vicinity of the constructed access roads. 3/30/07	Continue to monitor and maintain as necessary. See Erosion Control Section for more detail. 3/30/07	CB controls are in place

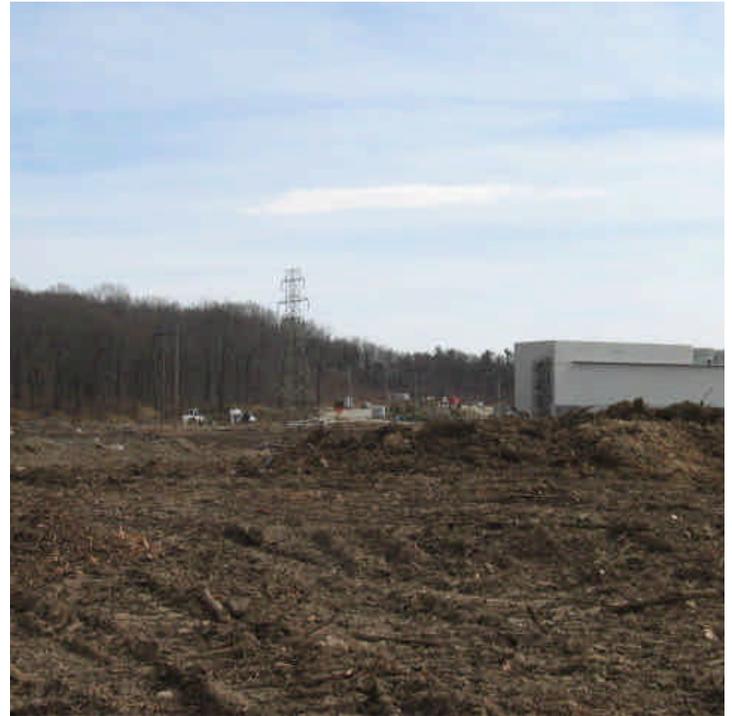
View of the clearing at the East Devon Substation site.

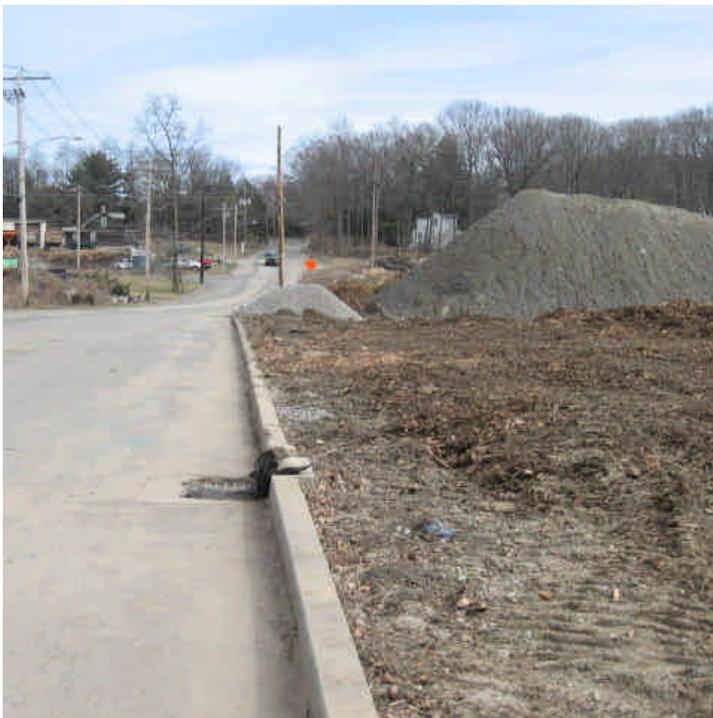
Plains Road has been swept recently and Silt sacks remain within the catch basins here.

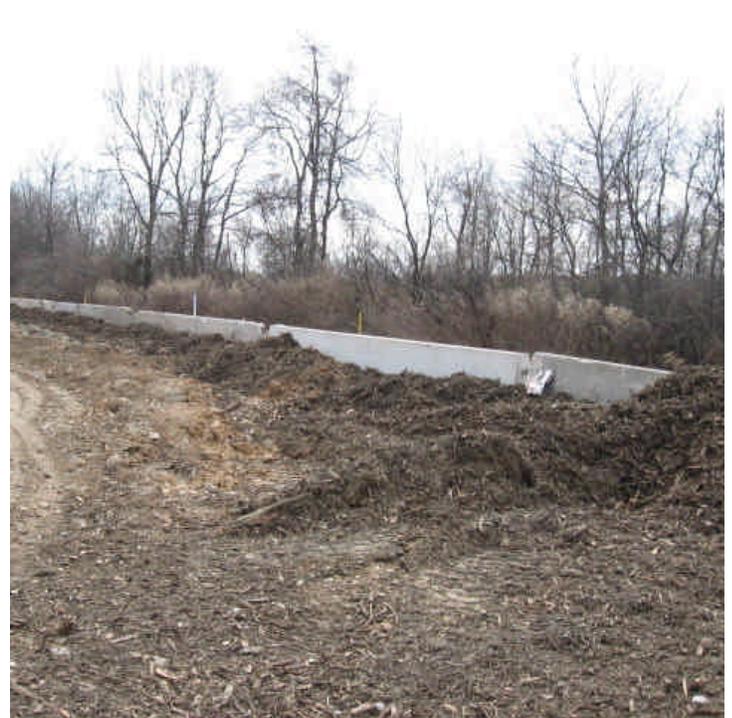
Mulch is in place at the jersey barriers along the western portion of the Substation site.

Areas of Inspection	Observation	Recommended Action	Corrected Action
	cleared. 3/30/07		
Erosion and Sediment Controls	<p>Jersey barriers remain along the western site boundary in an effort to contain soils and prevent off site sedimentation. Mulch has been placed on the adjacent soil for additional sediment control. 3/30/07</p> <p>“Silt saks” (or similar) remain within the CBs along Plains Rd. in the vicinity of the construction access points. Silt sak fabric was pulled over the curb drop inlet at those catch basins located immediately adjacent to the access points. 3/30/07</p> <p>A line of silt fence remains within the large cleared area. 3/30/07</p>	<p>Continue to monitor and improve as necessary. 3/30/07</p> <p>Continue to monitor and maintain as necessary. Evaluate methods to protect the curb drop inlets and prevent sedimentation as needed. 3/30/07</p> <p>Continue to add or adjust controls in the large open area of exposed soil as needed. However, the area is mostly contained at this time. 3/30/07</p>	<p>NA</p> <p>CB controls are in place</p> <p>NA.</p>
