Docket No. 272 – Development and Management Plan Inspection

Segment 4c Underground Line

Date: September 18, 2007

Location: Westport Avenue to the Norwalk Substation in the City of Norwalk

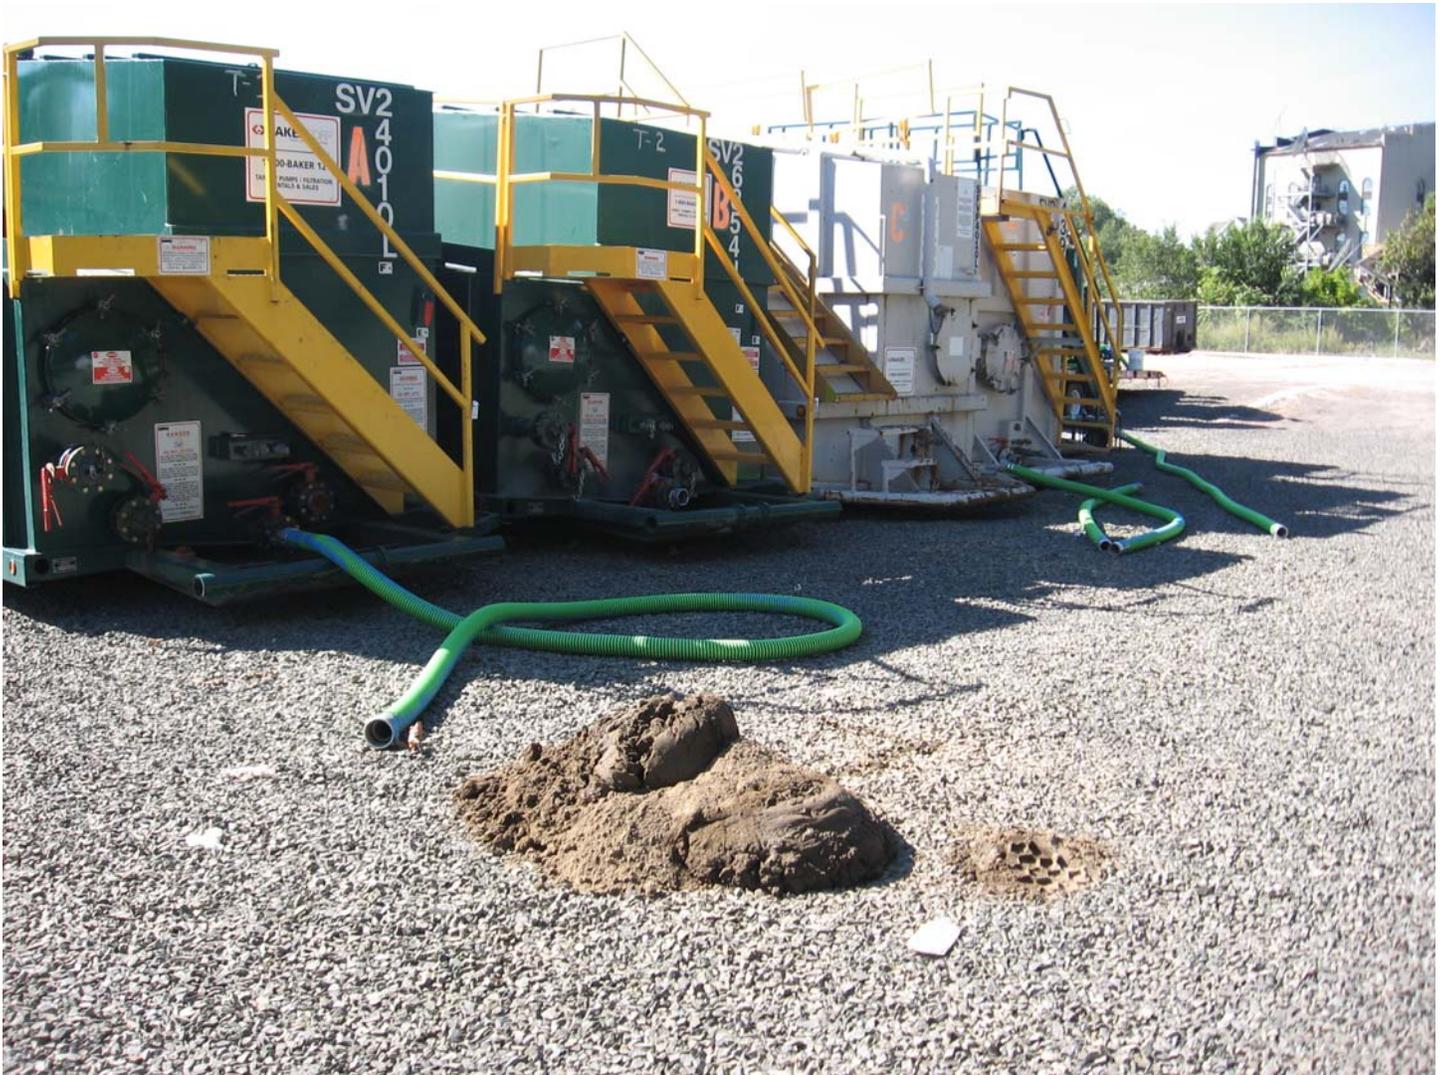
<p>Soils</p>	<p>A small pile of soil was observed within the Norwalk lay-down yard in an uncontained location. The soil appears to be from a vac truck used for the Glenbrook portion of the project. 9/18/07</p>	<p>Properly contain/dispose of soil. Provide proper containment if soil is to be routinely stored in this location. 9/18/07</p>	<p>Needs attention if soil is to be routinely stored here</p>
<p>State species of concern, threatened and endangered species.</p>	<p>According to the D&M plan, state-listed species are not located in this work area.</p>	<p>None</p>	<p>NA</p>
<p>Vegetative clearing (including trees to save or danger trees noted)</p>	<p>No clearing has been noted in this segment of the project at this time.</p>	<p>In general, continue to stabilize exposed soil as work progresses. If</p>	<p>NA at this time</p>

Photograph of the Norwalk laydown yard. A pile of soil was deposited in an uncontained location. It appears that this soil is from a vac truck used for the Glenbrook portion of this project.
