Middletown \ Norwalk Transmission Line Project
CSC Monthly Construction Report
UI Segment 3 and Singer Substation
May 2007

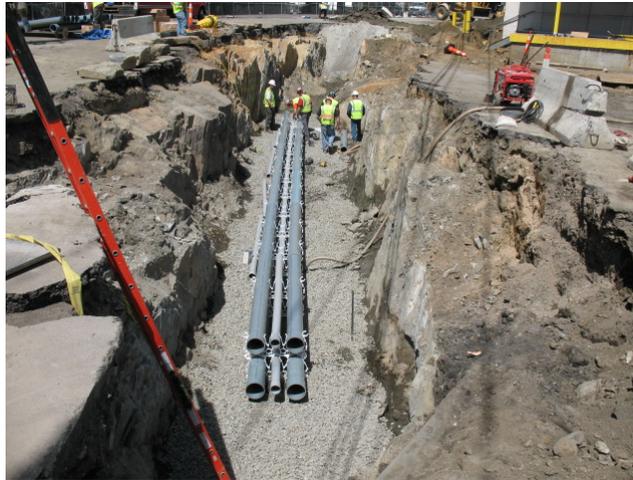
345kV UG conduit behind Dock Shopping Center in Stratford

At various locations in Bridgeport and Stratford, the excavation and installation of the 345kV duct bank has commenced. To date, 2,600 feet of the 29,568 total footage (8.8% complete) of the 345kV duct bank has been completed.

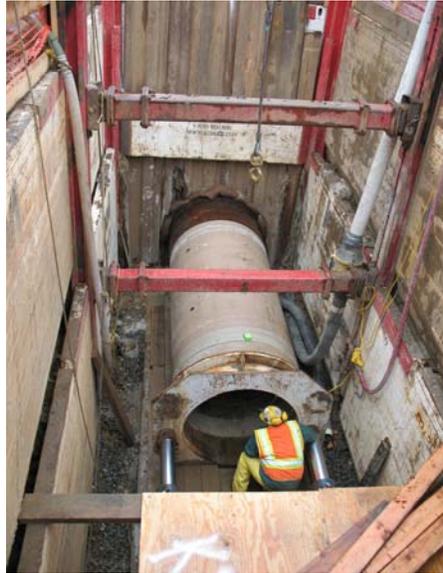
Jack & Bore casing being installed @ Bruce Brook

On Barnum Avenue, at the corner Sage Avenue, two jack and bore operations under Bruce Brook are underway. The one west of the corner is complete and the one east will continue during the month of June.

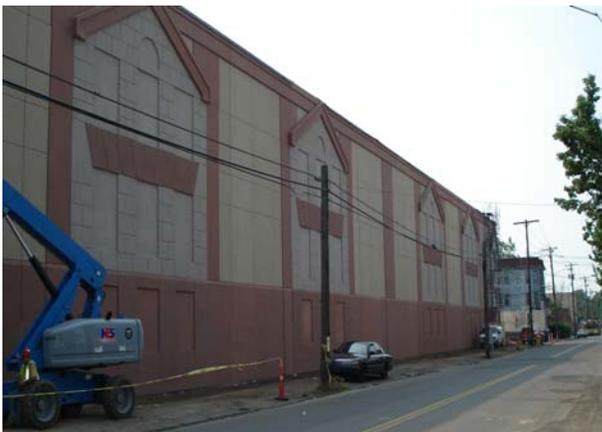
GIS building Architectural façade along Main St.

Delivery and installation of the structural steel for the GIS building was completed. Pre-cast architectural panels were delivered and installed on the GIS building. Roofing system for the GIS building was delivered and installed. Internal grounding and conduits continued to be installed in preparation concrete top slab installation. Several portions of the concrete top slab were poured in the GIS building. Foundations for the control building were completed, structural steel was installed and installation of the pre-cast panels commenced. Equipment foundations along the rear of the GIS building continued to be constructed.

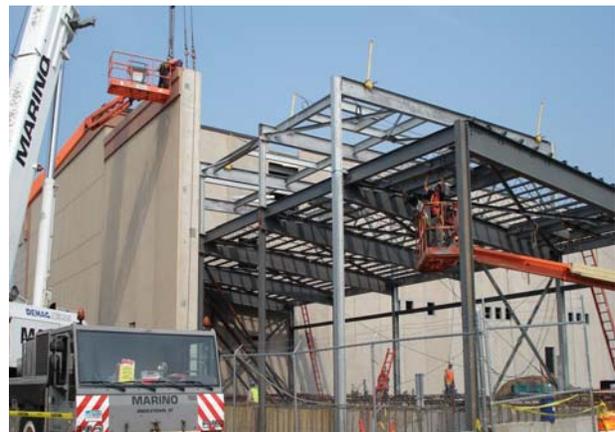
Installation of pre-cast panels on control building.
