**STORMWATER POLLUTION CONTROL PLAN
(SWPCP)
FOR FUSION SOLAR CENTER
SPRAGUE, CT
KLEINFELDER PROJECT # 20163850.001A**

**STORMWATER POLLUTION CONTROL PLAN
(SWPCP)
FOR FUSION SOLAR CENTER
SPRAGUE, CT**

July 1, 2016
Kleinfelder Project #: 20163850.001A

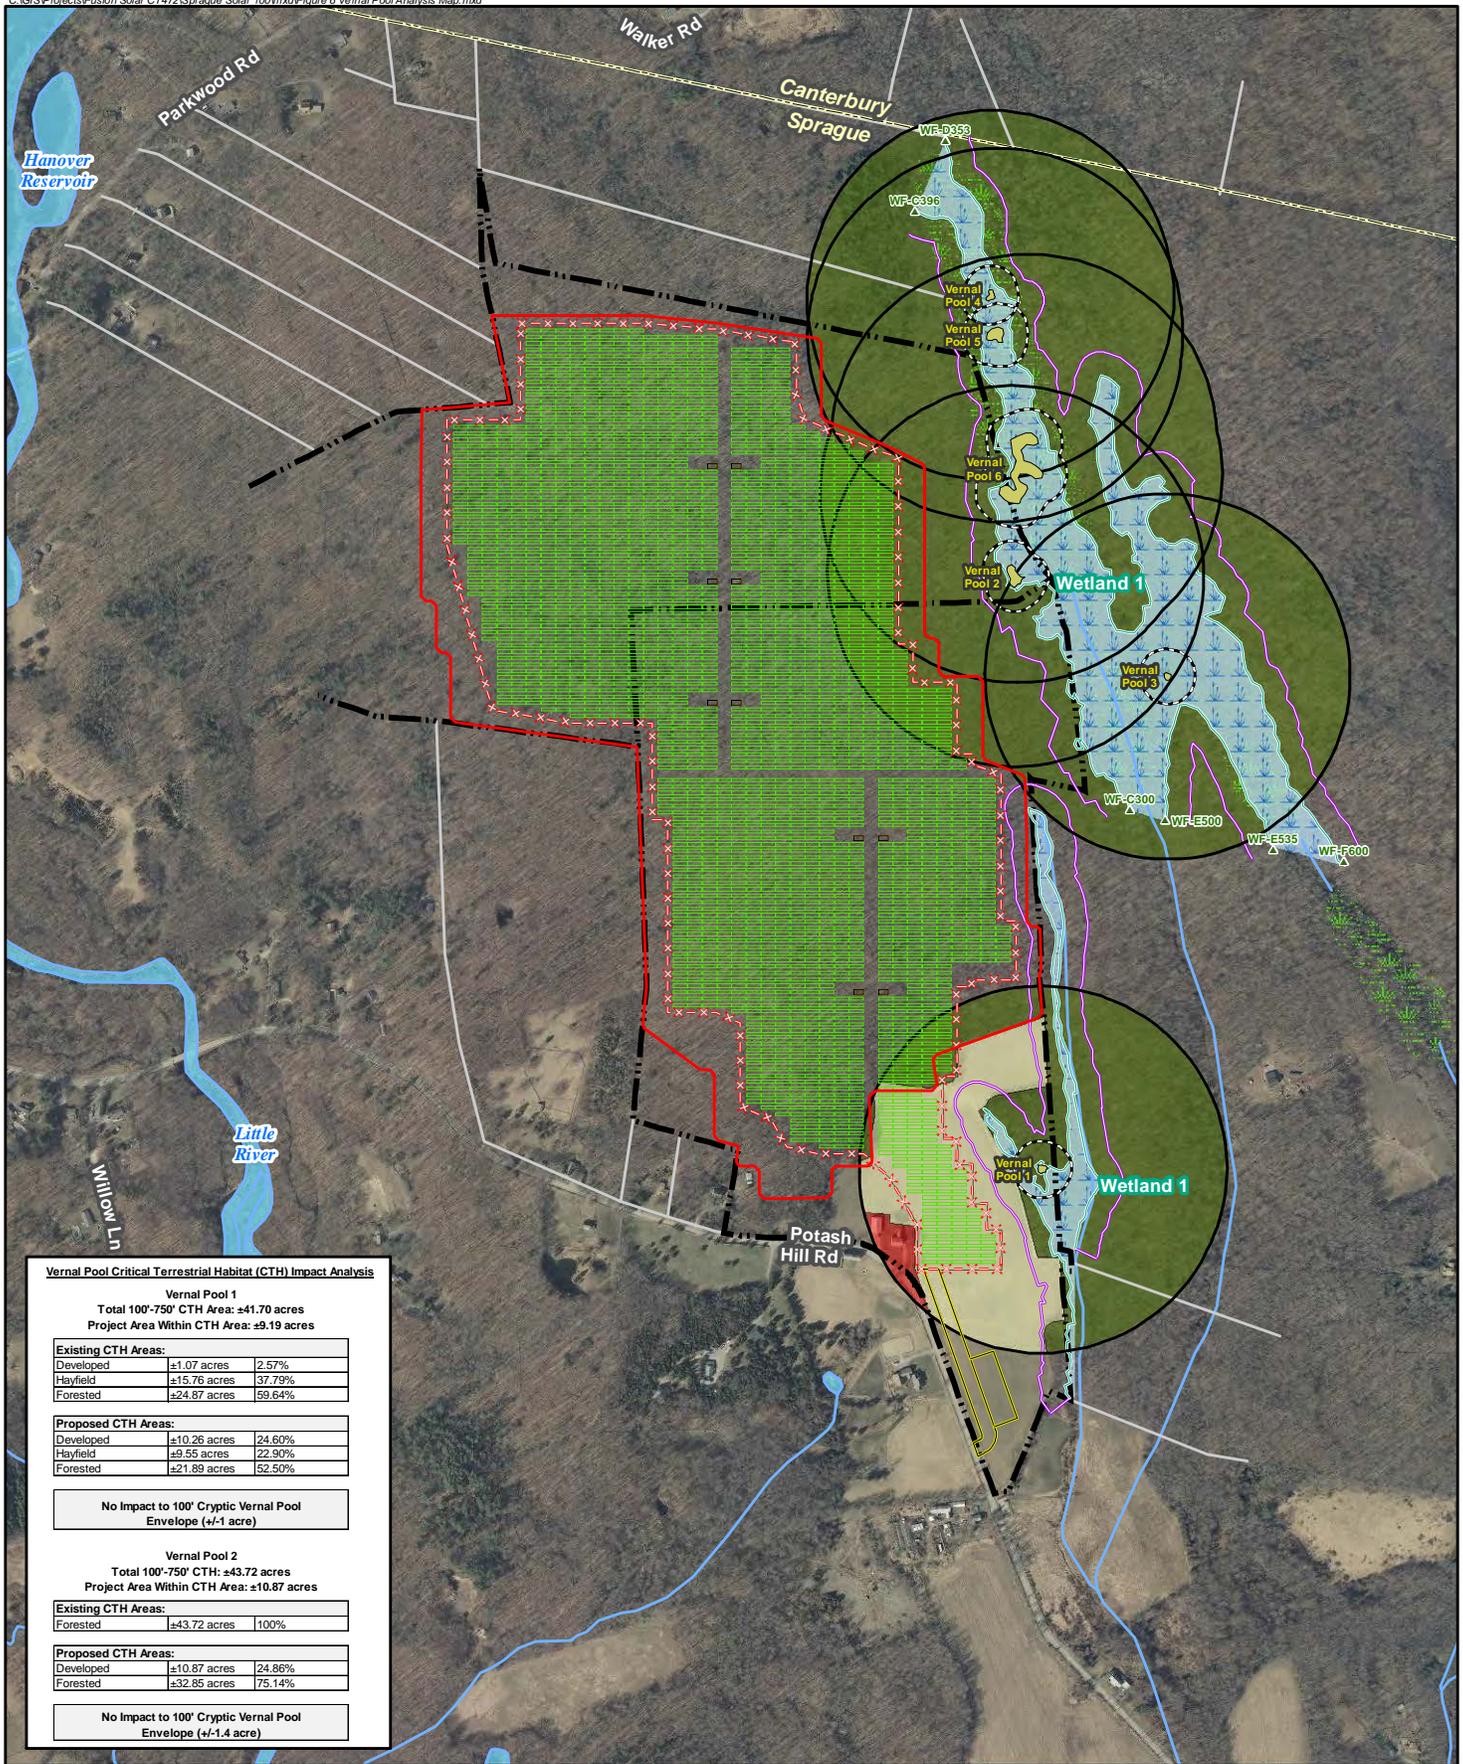
Vernal Pool Critical Terrestrial Habitat (CTH) Impact Analysis

Vernal Pool 1
 Total 100'-750' CTH Area: ±41.70 acres
 Project Area Within CTH Area: ±9.19 acres

An analysis of the post-development conditions using the BDP methodology was conducted and is illustrated on Figure 6, *Vernal Pool Analysis Map*. No direct impact to any vernal pool is proposed and no activity is proposed within any VPE conservation zone.

The proposed development predominately lies within the CTH of Pools 1 and 2, but will also affect a small portion of the CTH of Pools 5 and 6. The post-development BDP analysis was conducted for Pools 1 and 2, and determined that Pool 1 will have an increase in developed land from 2.57% (pre-development) to 24.6% (post-development). However, the majority of this increase will occur as a result of development within the hayfield which offers sub-optimal terrestrial habitat for vernal pool wildlife. The loss of forest habitat within the CTH of Vernal Pool 1 will total only 2.98 acres or 7.1% of the CTH. The nearest proposed activity to Vernal Pool 1 is approximately 280 feet.

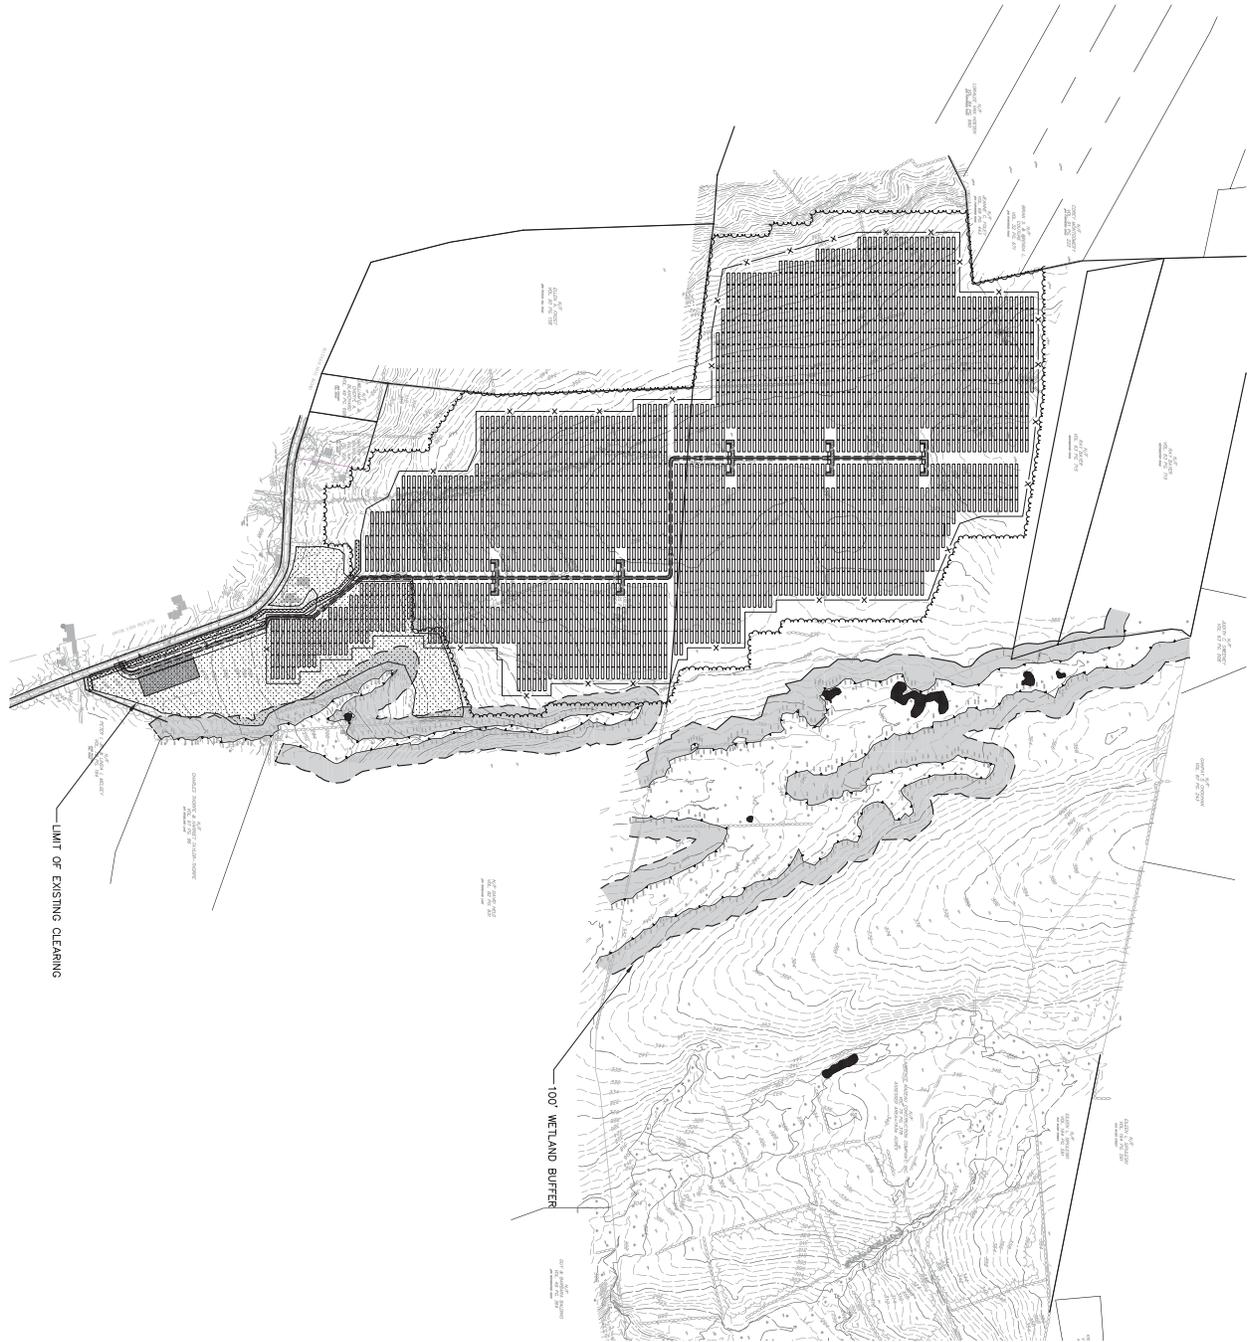
Project Site Plans

LIMIT OF EXISTING CLEARING

100' WETLAND BUFFER
