STATE OF CONNECTICUT
DEPARTMENT OF TRANSPORTATION
STATE PROJECT NO. 300-097
AGREEMENT NO. 9.07-01(10)

MECHANICAL/ELECTRICAL INSPECTION REPORT

METRO-NORTH RAILROAD, DEVON BRIDGE
OVER HOUSATONIC RIVER - STRATFORD, CT
CONNDOT BRIDGE NO. 08080R
MAIN LINE MP 60.42

INSPECTION COMPLETED ON:
MARCH 25, 2012

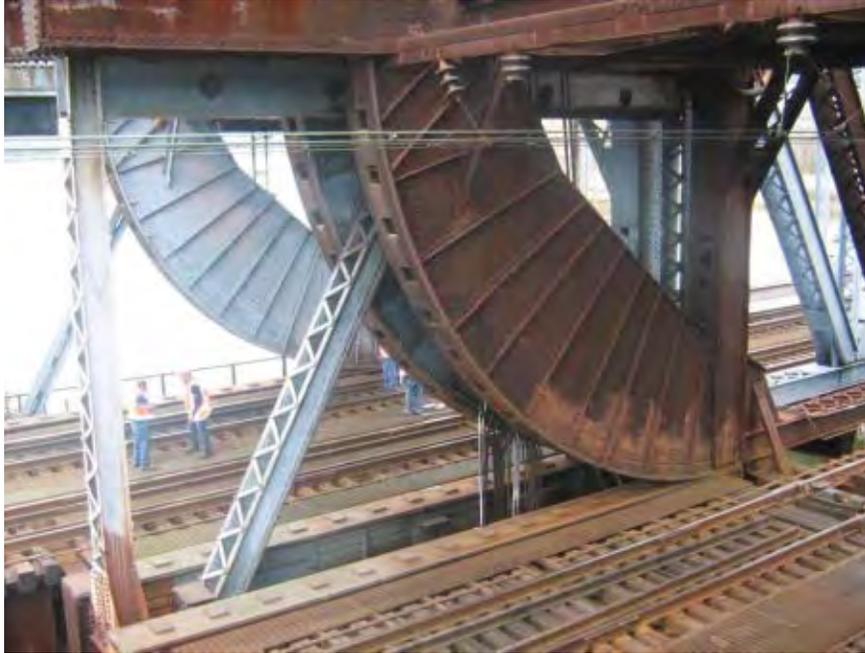
Photo M-31. North (painted) and South (unpainted) Leaf Tread Assemblies.

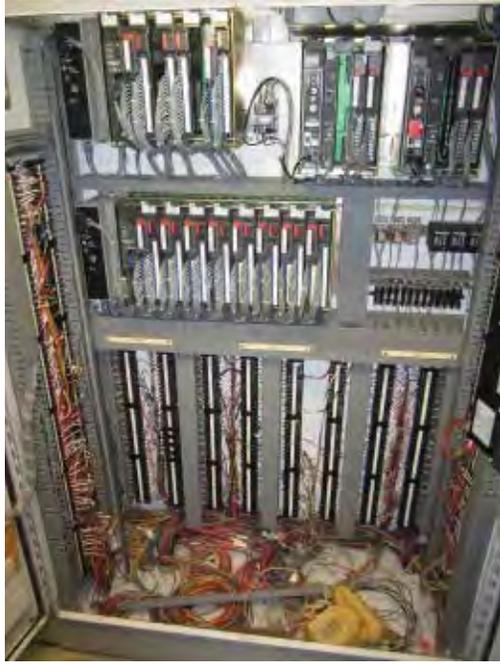
Photo E-07. PLC enclosure.

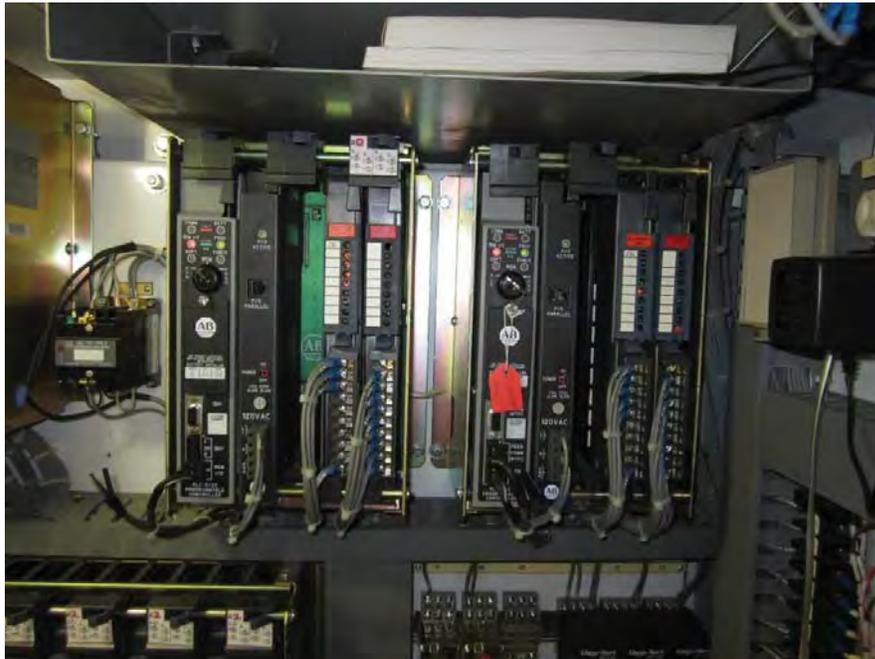
Photo E-08. PLCs processors located in the PLC enclosure.

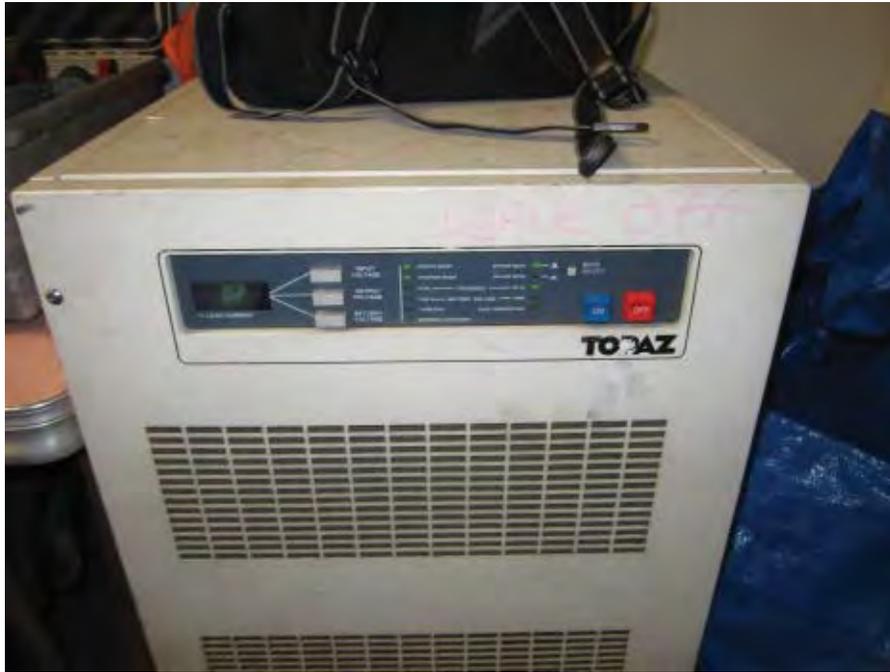
Photo E-09. Uninterruptible Power Supply (UPS).

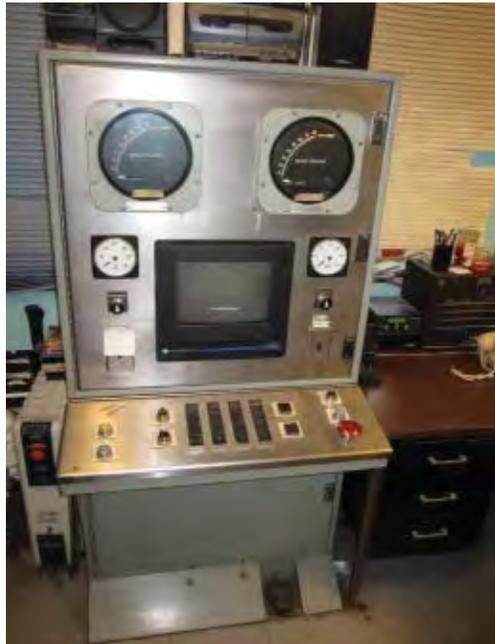
Photo E-10. Operator's Control Desk.

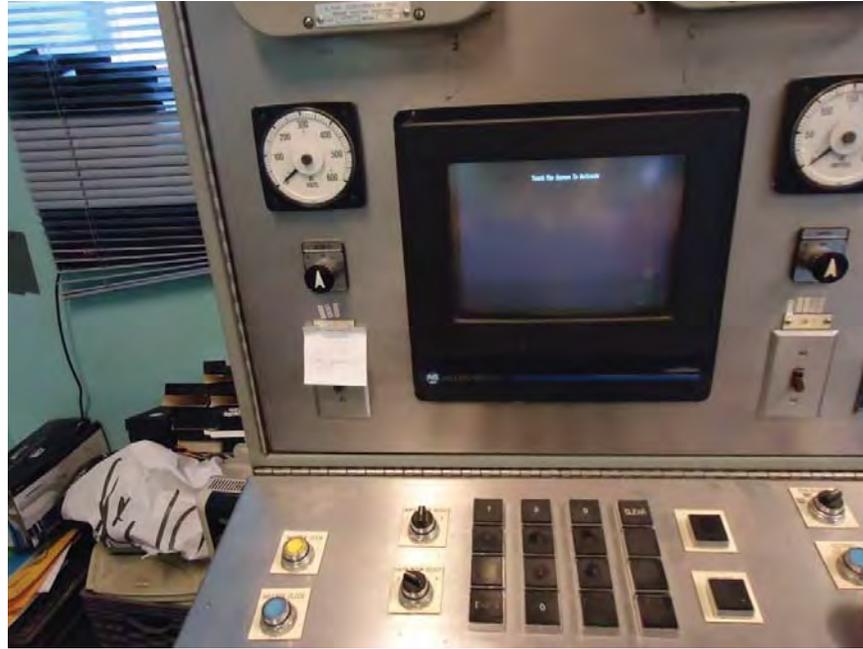
Photo E-11. Operator's Control Desk voltmeter, ammeters, bridge Position Indicator and PanelView display.

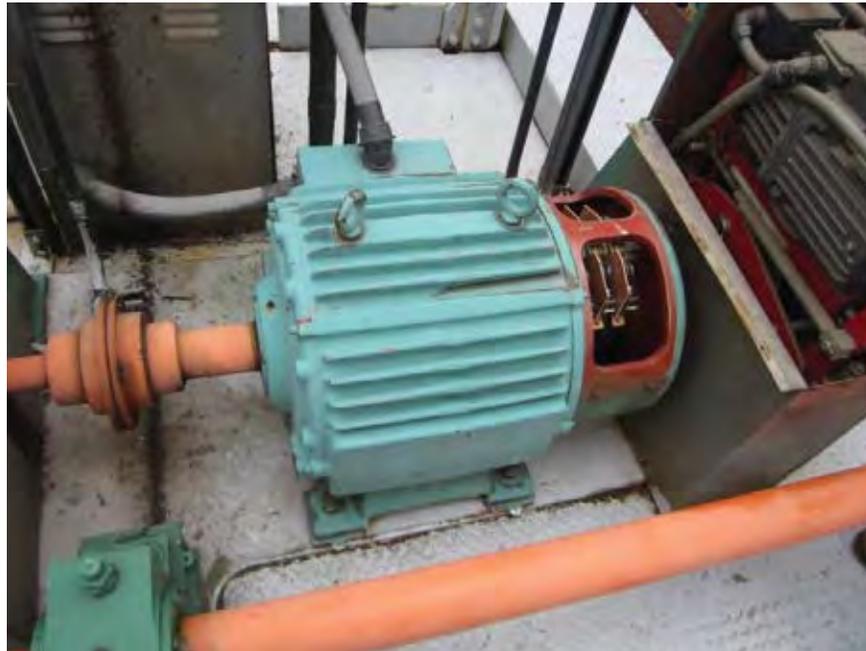
Photo E-12. Typical span drive motor.

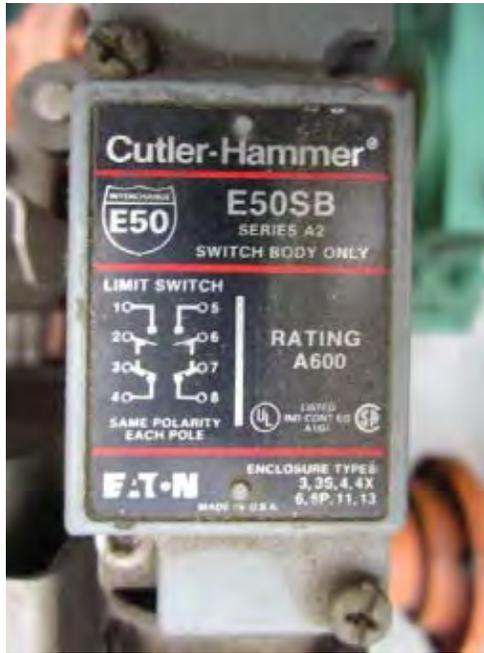
Photo E-15. Typical motor brake limit switch.

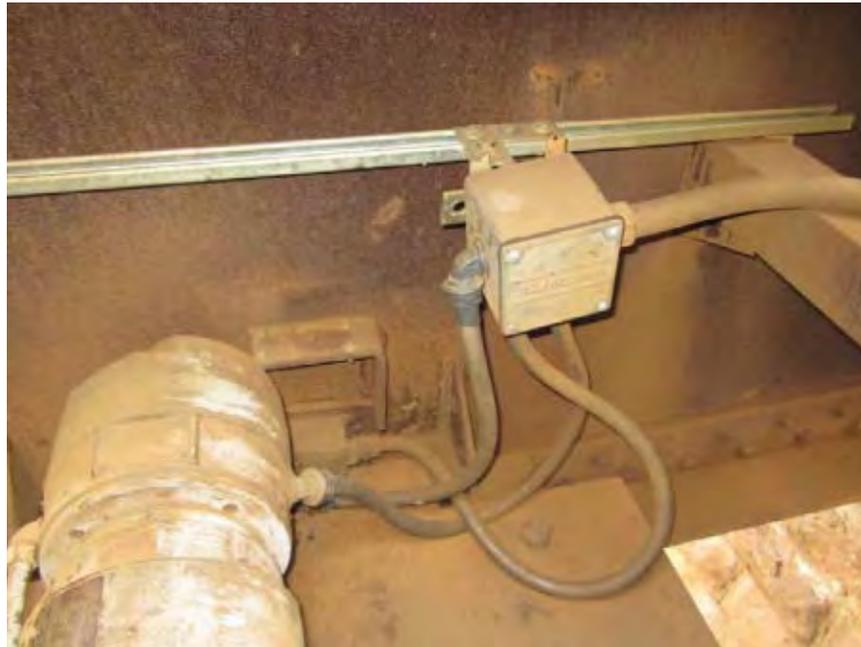
Photo E-16. Span lock motor.

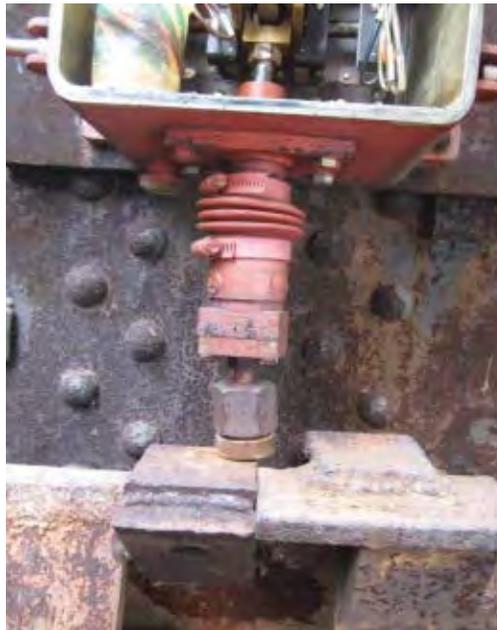
The South span seated switch #2 Seated Limit Switch was found to have a bent plunger. It is recommended to replace or fix the plunger (See Photo E-18).

Photo E-18. Seated limit switch with bent plunger rod.

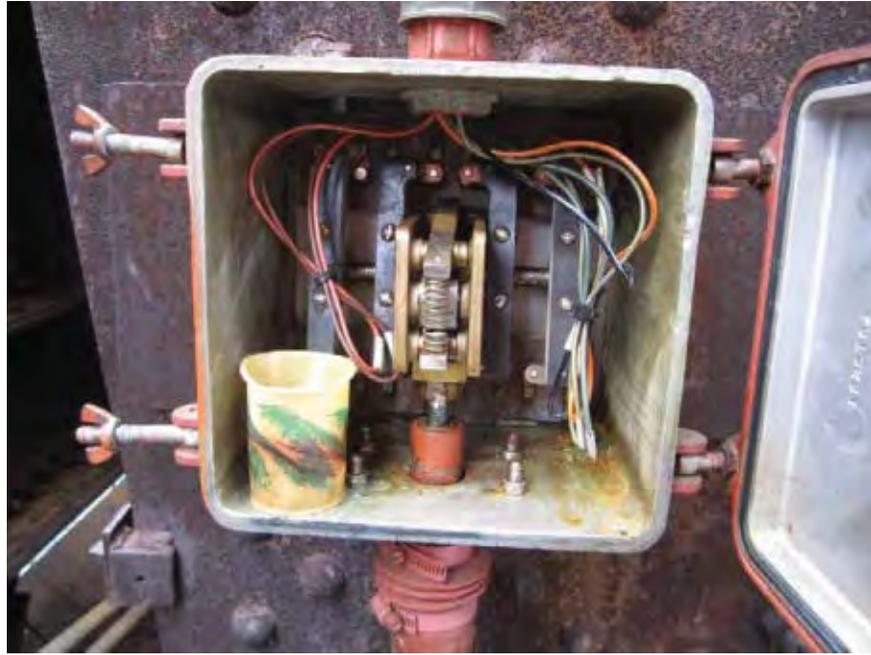
Photo E-19. Typical Interior of Seated Limit Switch.

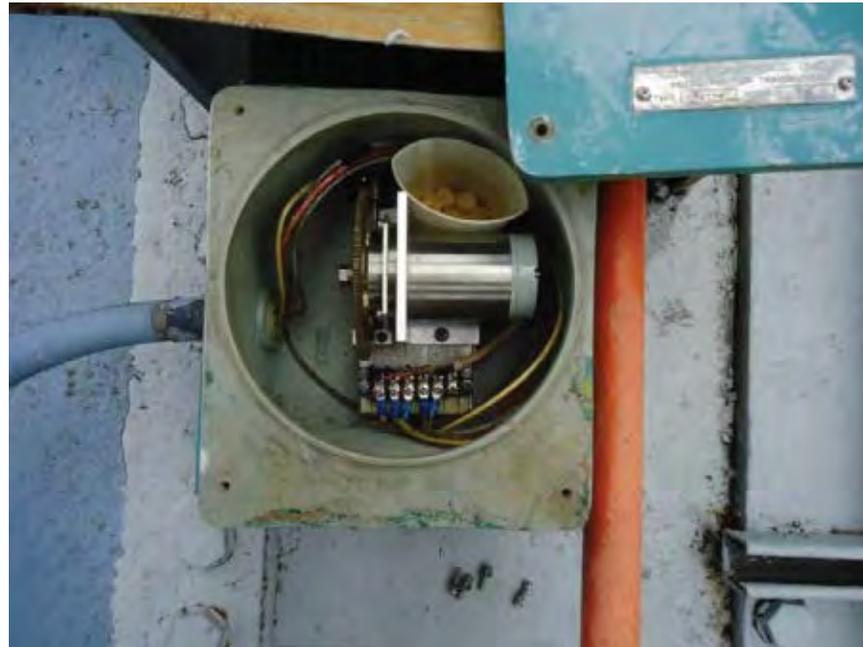
Photo E-20. Typical Span Position Indicator.

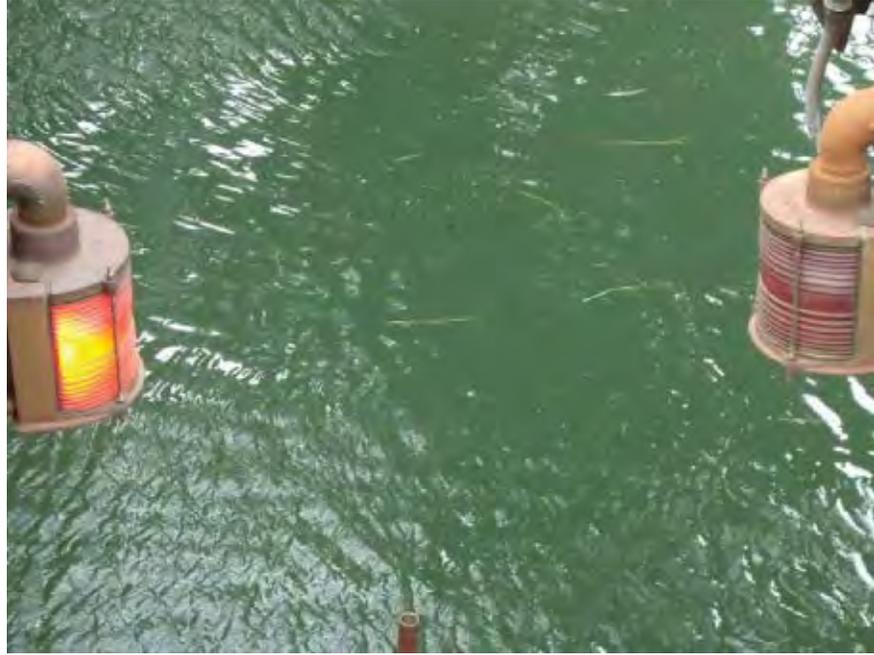
Navigation lighting was inspected and found to be in fair condition. There are fender navigation lights on the west pier fender and east pier fender. There are two pivoting bascule clearance navigation lights at the toe end of the leaves, one on the north side of the north leaf and one on the south side of the south leaf. These are considered outboard and are red and green to control marine traffic. There are also two fixed navigation lights at the toe of each leaf, one on the north side of the south leaf and one at the south side of the north leaf. These are considered inboard, are red and also are

Photo E-21. In-board Navigation Lights.

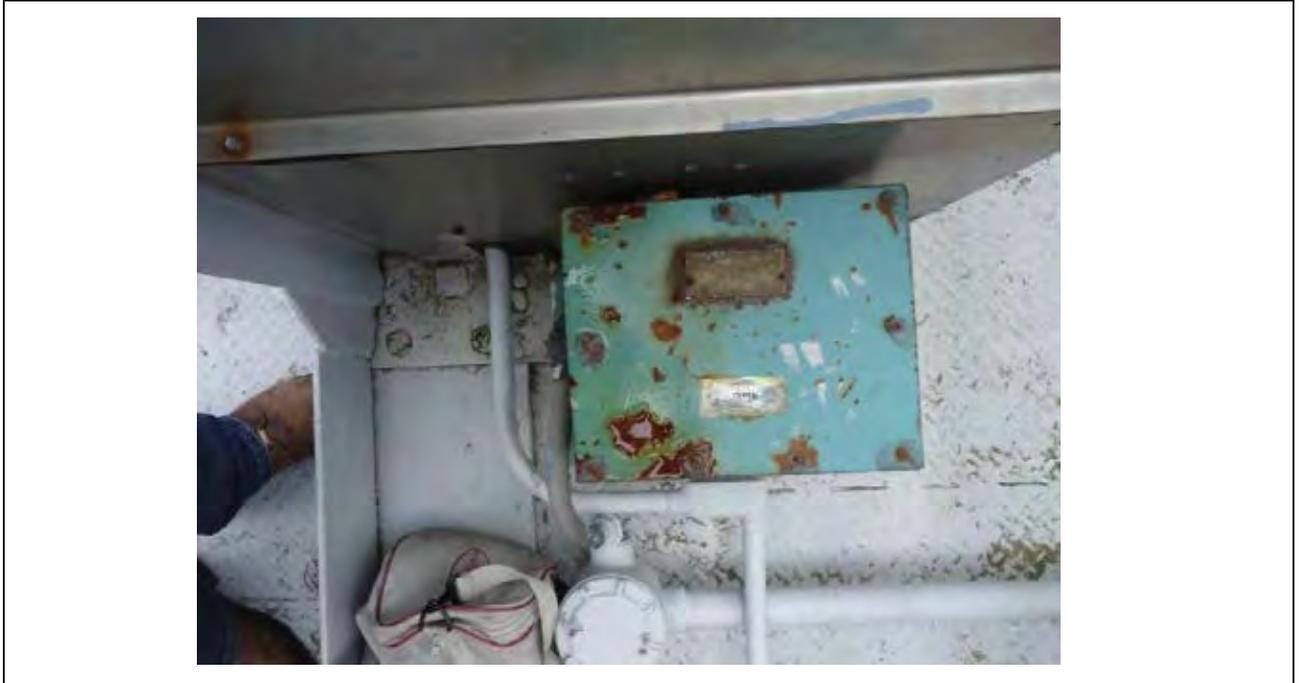
The conduit and raceway system on the bridge is in generally good condition, with no obvious corrosion or major failures although there are many conduits that are loose or ~~have missing conduit clamps~~. Much of the below deck conduit is supported on electrical framing channel supports secured to the structure with beam clamps. This type of connection can be problematic in a high vibration environment and requires regular maintenance. Damaged flexible conduit attached to north span position indicator was found ~~which needs to be replaced~~ (See Photo E-23 and Photo E-24).

Photo E-24. Span Position and Speed Indicator.
