**REHABILITATION STUDY REPORT**

**STATE PROJECT NO. 126-170**

**BRIDGE NO. 00571A  
ROUTE 8 OVER THE HOUSATONIC RIVER**

**July 2014**

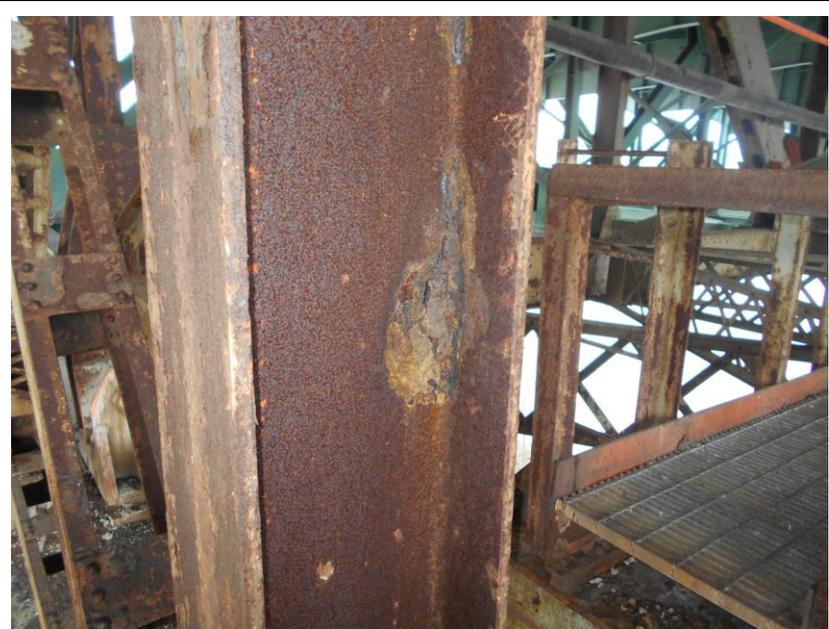
**Photo 2: Bridge 00571A, Perforation and Section Loss in Vertical at Steel Truss Bent at Pier No. 8.**

Alternative Repair Option No. 5: Replacement of all this bracing members of the original steel truss bents at Piers 8 and 11 is the recommended alternative to the repair and painting of these severely deteriorated steel bracing members. See **Figure 7** for the proposed repairs to the steel truss bent at Pier 8.

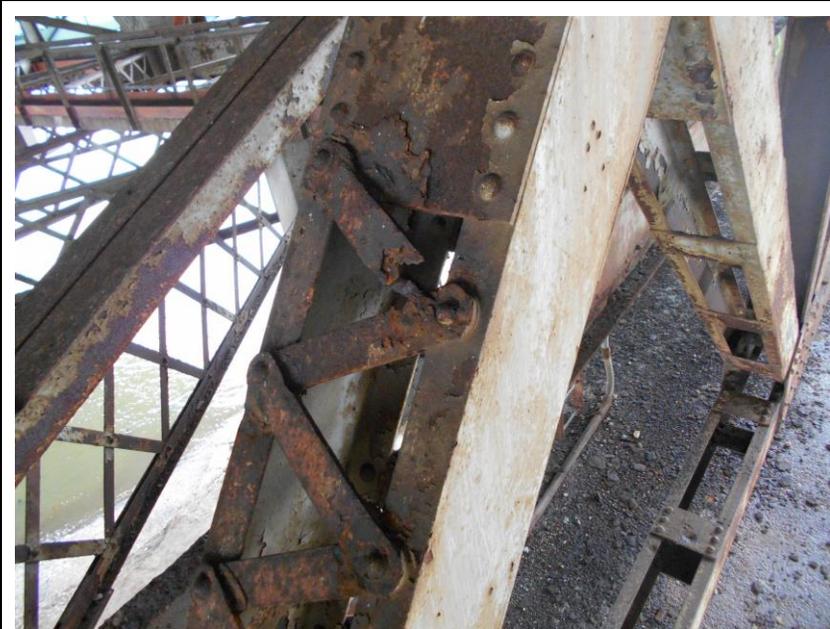
**Photo 3:** Bridge No. 00571A, Perforation in Lacing Member of Bracing in Steel Truss Bent at Pier No. 8.

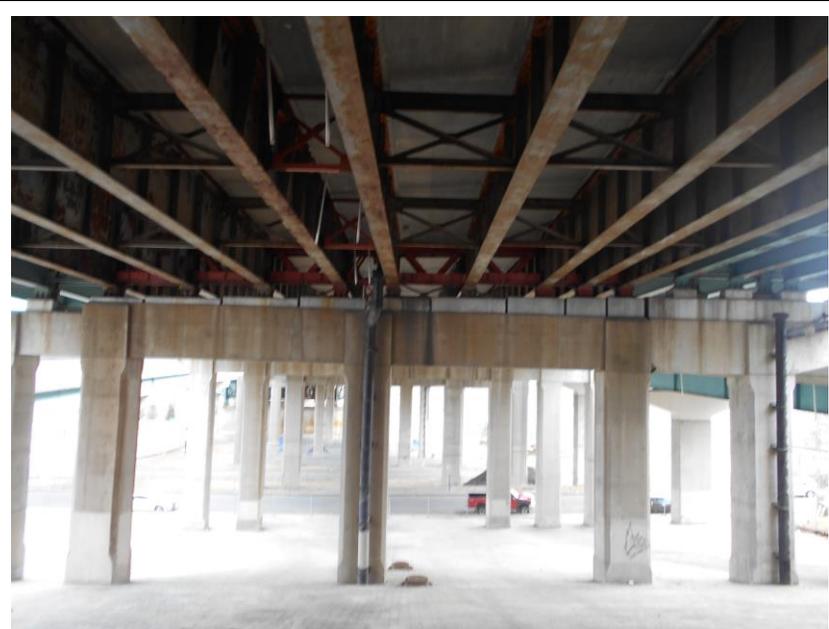
**Photo 4:** Bridge 00571A, Original Steel Girders in Span No. 2. Note Weep Hole Drains in Median Bearing.

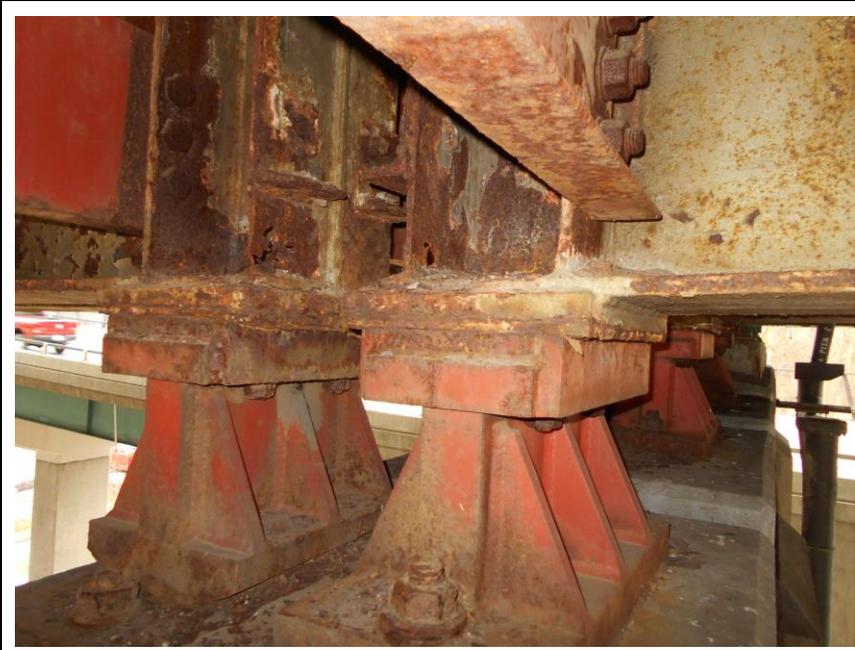
**Approach Spans:** The main issue for the approach spans for Bridge No. 00571A is the condition of the approach span girders at their ends under the deck joints at the piers. The condition of the girder webs and bearing stiffeners in these areas, as shown in **Photos 5, 6 and 7**, show heavy rust, severe section loss and several perforations developing in the original girder webs and their bearing stiffener plates. The condition survey confirmed the losses and perforations, as reported in the 2013 Bridge Inspection Report. The other element of concern at the approach spans are fixed bearings of the original girders. These have heavy rust, severe section loss, and severe loss to the anchor bolt nuts. Although replacement of all original fixed bearings is not warranted, we anticipate that the losses to the anchor bolts (see **Photos 9 and 10**) will require providing additional restraint for these bearings.

**Photo 5:** Bridge No. 00571A, Perforations in Bearing Stiffeners at Girder Ends. Girder G8 in Spans 3 and 4 at Pier No. 2.

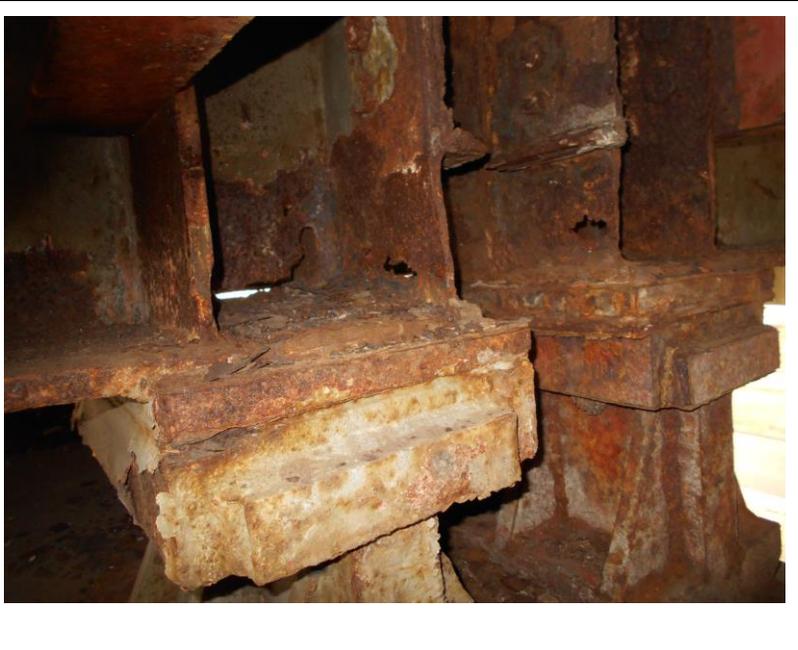
**Photo 6:** Bridge No. 00571A, Perforations in Web and Bearing Stiffeners at Girder Ends at Pier No. 3.

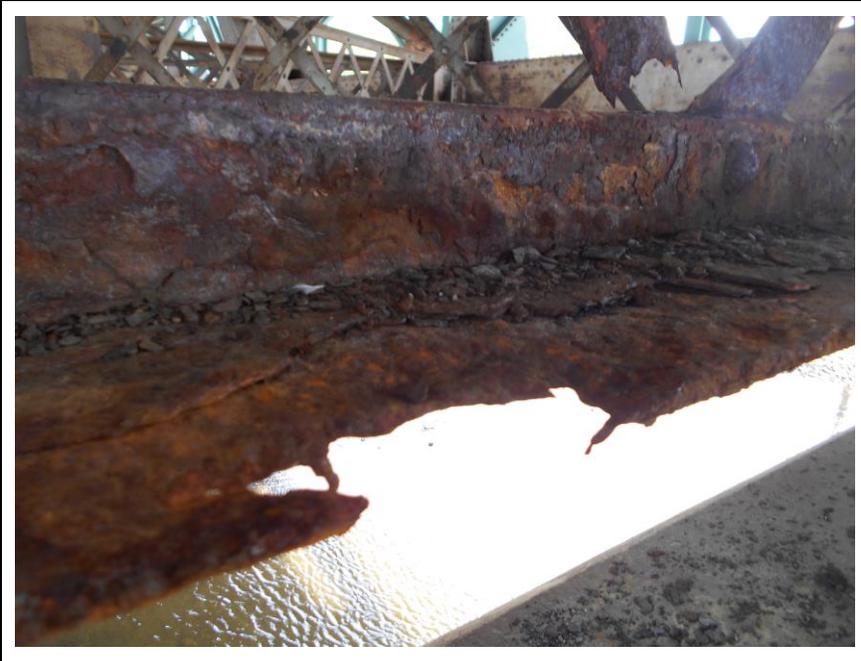
Truss Bracing and Inspection Walkway: The original top cross bracing and sway bracing, consisting of back to back angles, has impact rust between the angles, but as our condition survey has confirmed, they do not warrant replacement. The original truss bottom cross bracing and bottom lateral bracing that have lacing bars that form the web between the double angle top and bottom flanges were confirmed, in our condition survey, to require repairs and possible replacement due to the deterioration and complete loss of many of the lacing bars. See **Photos 11, 14, 15, and 16**.

**Photo 11: Bridge No. 00571A, Lattice Member and Cross Bracing Section Losses.**

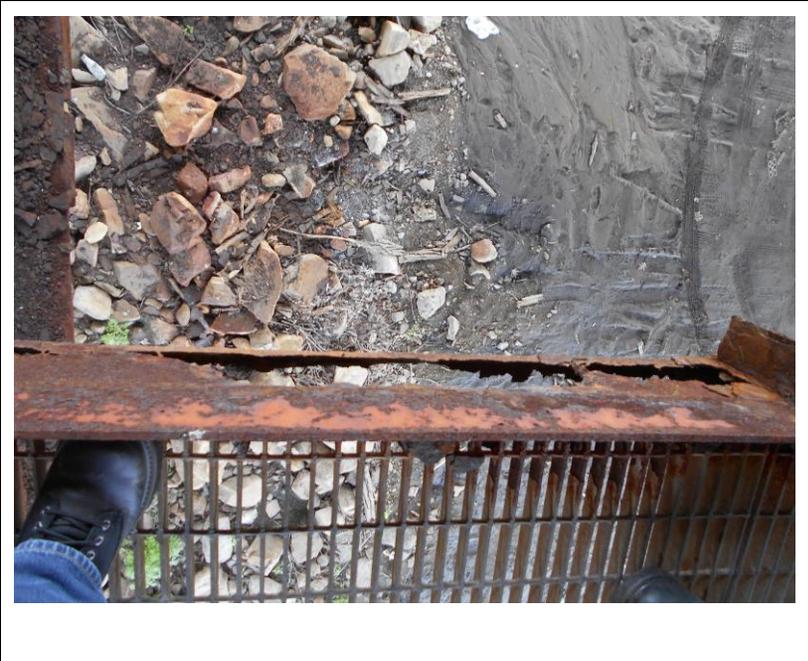
**Photo 12: Bridge No. 00571A, Severe Section Loss of Inspection Walkway Channel Member.**

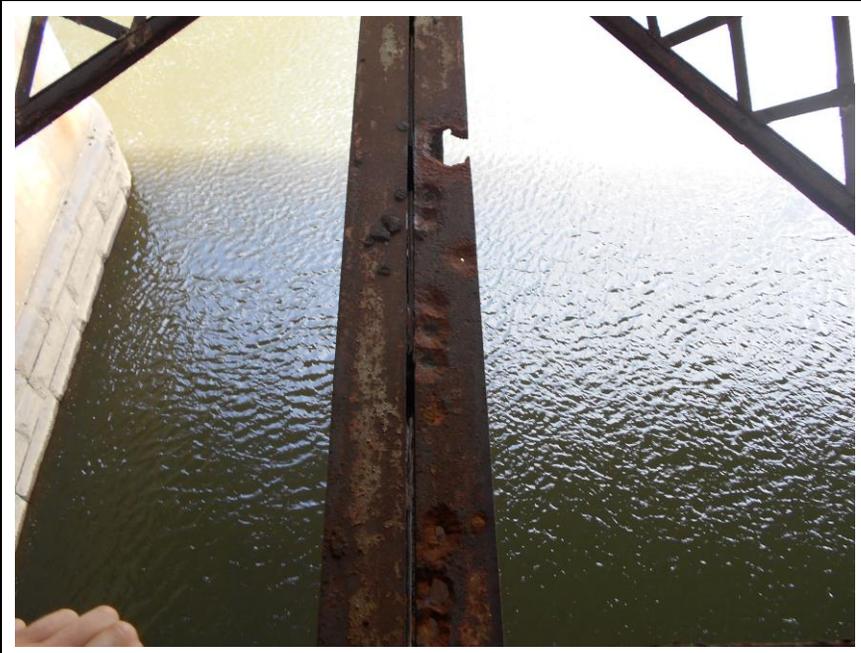
**Photo 15:** Bridge No. 00571A, Cross Bracing Member Perforation and Section Loss.

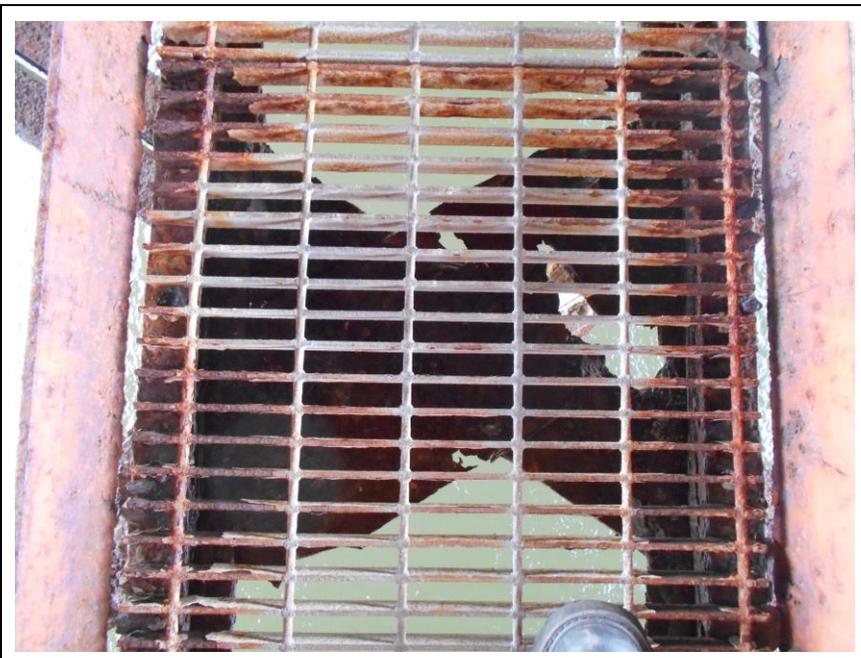
**Photo 17:** Bridge No. 00571A, Gusset Plate Section Loss and Perforations.

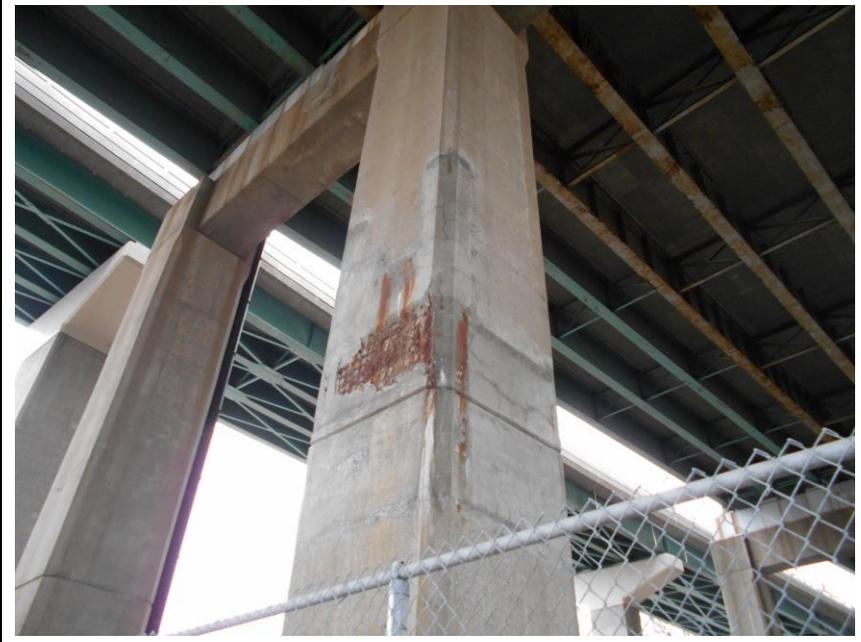
**Photo 19:** Bridge No. 00571A, Exposed Rebar at Pier No. 5.

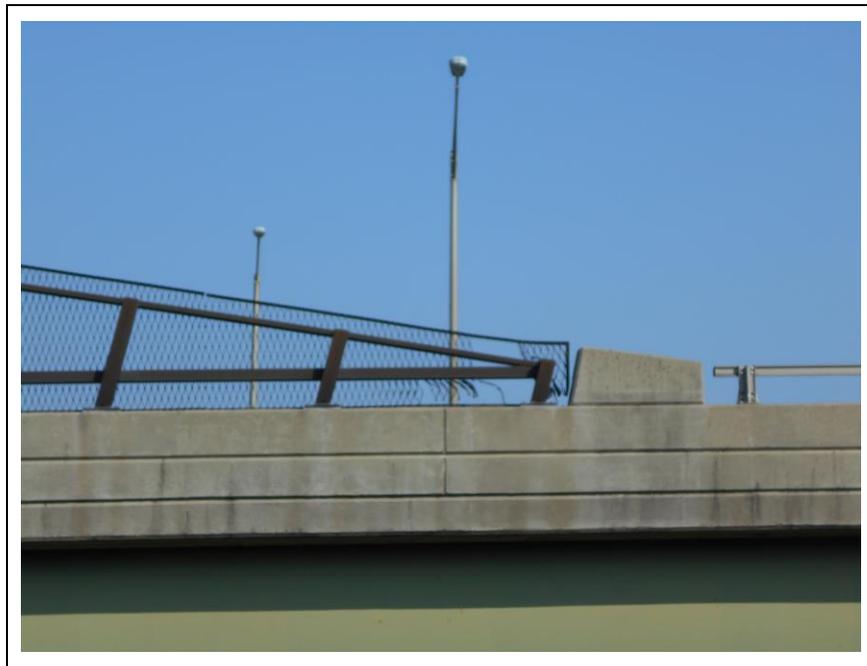
**Deck:** Our condition survey of deck elements was limited due to no traffic control on Route 8, but the elements to be addressed in the rehabilitation report are limited to the aluminum fencing and bridge drainage. **Photos 21 and 22** show the damage to the fencing that will be repaired as proposed in **Section V**, and **Photos 27, 28 and 29** confirm the clogged scuppers along the western gutter line of Route 8 Southbound and those in the pedestrian sidewalk. Other elements such as joints and the newly placed overlay continue to function properly as indicated in the 2013 Bridge Inspection Report. See **Photos 30 and 31**.

Fencing: The extensively damaged anodized aluminum fence mounted to the east parapet in Span Nos. 7-9 is adjacent to traffic as is the fencing mounted to the west parapet in Span Nos. 5-6. The fencing mounted to the west parapet in Span Nos. 9-12 is adjacent to the sidewalk and not exposed to vehicle traffic and associated vehicle impacts. The anodized aluminum fencing is flush with the face of the parapet as shown in **Figure 4**. This may contribute to the damage that the fencing has experienced. The proposed repair is to reset the fencing back with the use of new top and bottom rail elements. The replacement of the existing grill for the full length of the fencing is also recommended. The fencing on the east parapet also runs the full length of Ramp D on Bridge No. 00571C. A detail of this repair is shown in **Figure 5**. If the fencing rails are reset back and the grill replaced on the fence mounted to the eastern parapet in Span Nos. 7-9 is done then this repair should also be performed on the ramp bridge's eastern parapet for its full length. (Cost of repair to ramp fencing is included in the cost estimate)

**Photo 21: Bridge No. 00571A, Extensive Aluminum Fencing Loss.**

Alternative Repair Option No. 1: An alternative option is the replacement of the existing anodized aluminum fence mounted to the east parapet in Span Nos. 7-9 and mounted to the west parapet in Span Nos. 9-12 with metal bridge rail. The fencing seems to have been placed as protection for railroads beneath these spans as shown in the detail from the reconstruction plans shown below. The rail lines along Canal Street are no longer present. There is no need for the protection that this 5'-0" high fencing provided, in parts of the bridge that do not have sidewalks. The post spacing for the fencing is the same post spacing for

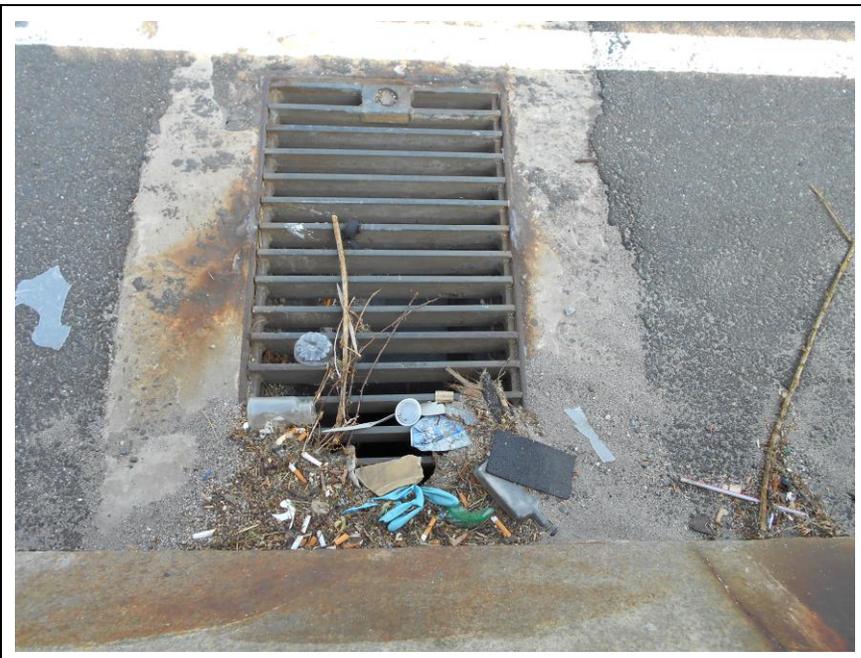
**Photo 27: Bridge No. 00571A, Partially Clogged roadway Scupper.**

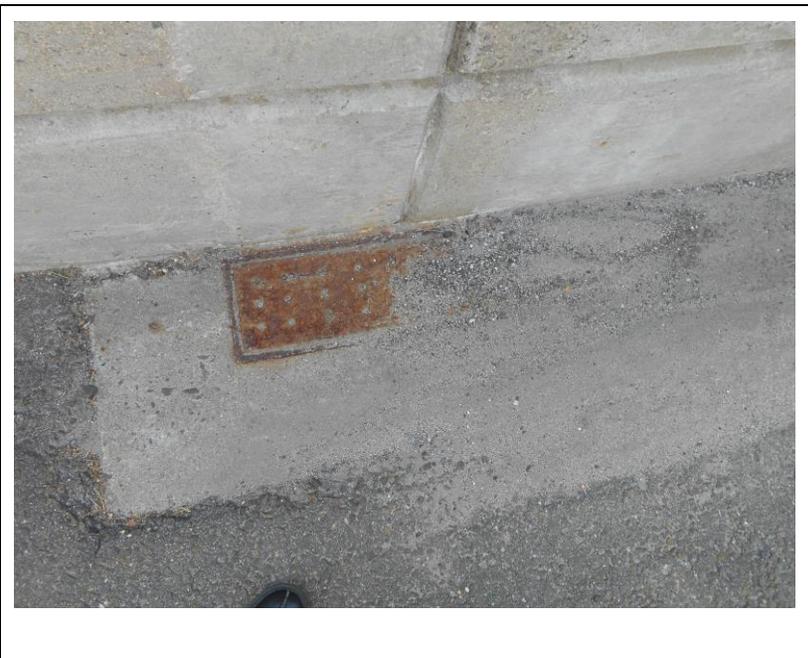
**Photo 28: Bridge No. 00571A, Heavily Clogged pedestrian sidewalk Scupper.**

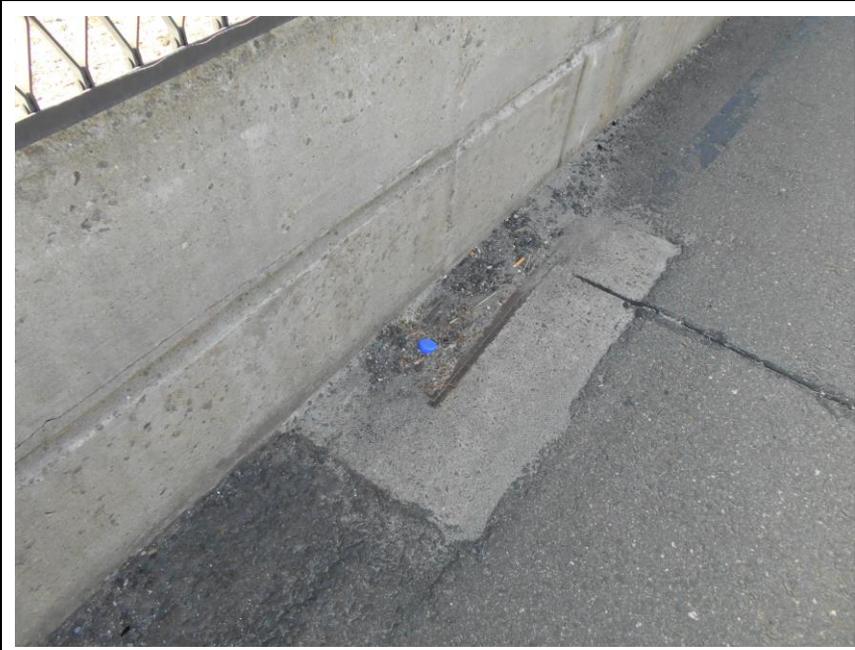
**Photo 29: Bridge No. 00571A, Severely Clogged pedestrian sidewalk Scupper.**

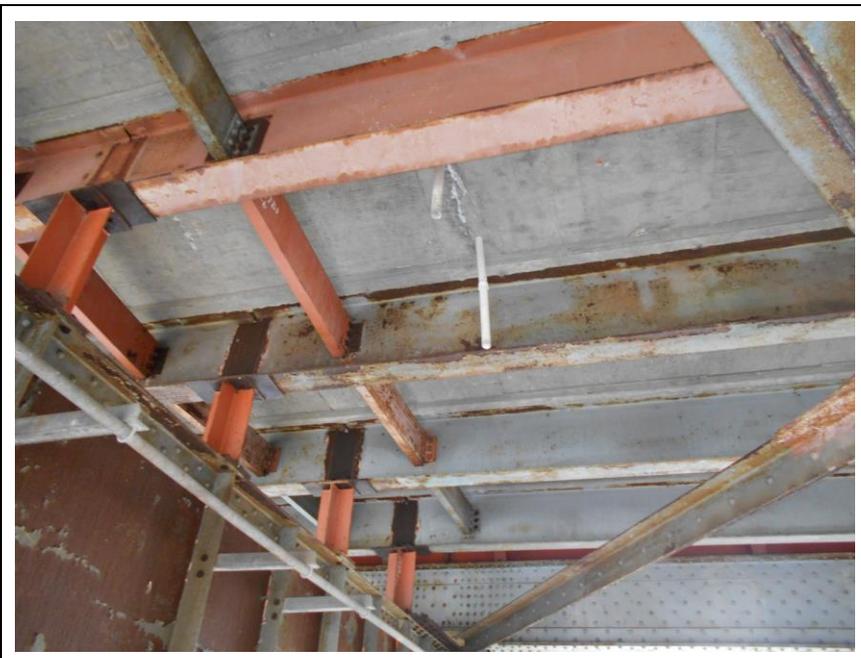
**Photo 35:** Bridge No. 00571A, typical weepholes spaced longitudinally throughout the length of the bridge.

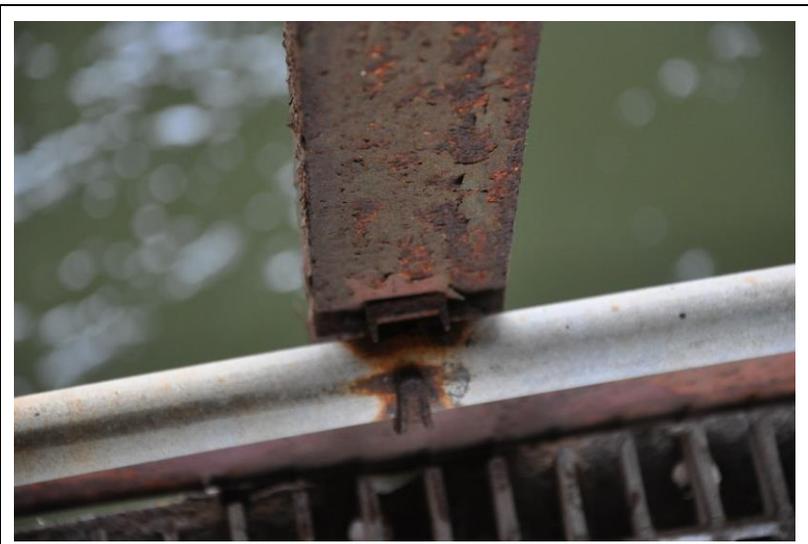
**Photo 36:** Bridge No. 00571A, 1" RGS Conduit mounted to railing on Lower Inspection Catwalk.

- Furnish and install new navigation lights with pivoting pendants and service chains.
- Replace 1" RGS conduit in its entirety along with cables (2/C #10 + GND). Conduit will be replaced up to existing box located on the underside of the bridge above the Canal Street.
  - Furnish and install RGS/SS conduit bodies, covers and supports.
  - Consider outer coating (PVC) of RGS conduit to further protect it from corrosion.
- Furnish and install new cast-iron gasketed covers for existing cast-iron junction boxes and attach them using vandal-resistant screws.

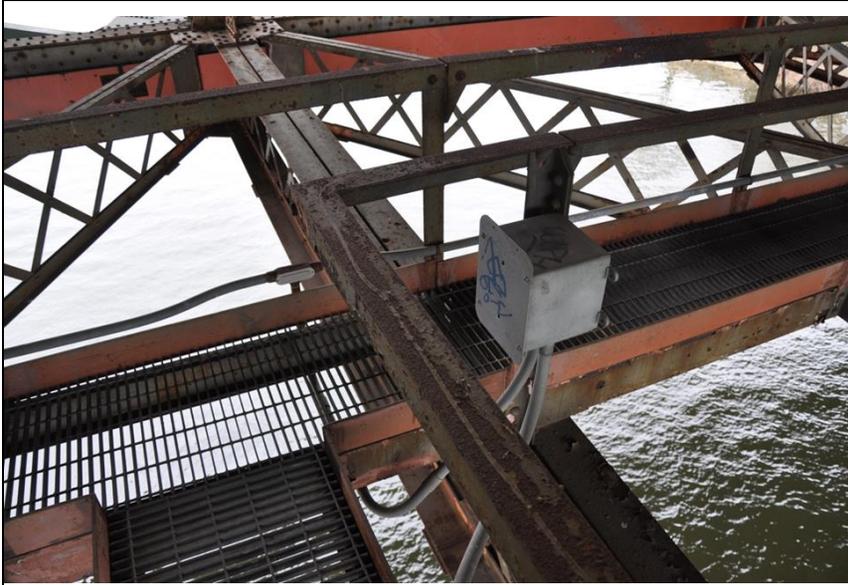
**Photo 39: Bridge No. 00571A, Cast Iron Junction Box for Navigational Lighting.**

See sheets 56-61 and Photos 39 & 40.
<b>UTILITIES TYPE/SIZE:</b>	6	There is a junction box with a missing cover and exposed wires at the steel bent over Pier 8 (Shared with Bridge No. 00571C).  See sheet 280.
<b>CONSTR JOINTS:</b>	8	-
<b>EXPANSION JOINTS:</b>	6	Asphaltic plug joints at Piers 1-7 and at both abutments. There are isolated adhesion and cohesion cracks in the shoulders up to 3' long and open up to 1/8" wide. Random areas of active leakage were noted below during this inspection.  Strip seal joints at Piers 8-11. Concrete headers have random transverse cracks and areas of light scale. Joint glands have heavy sand accumulation. Evidence of past leakage was noted below during this inspection.  Longitudinal pourable seal joints between Span 6 & Br. 00571B and between Span 8 & Br. 00571C have light to heavy sand accumulation and adhesion cracks up to 1' long.  Longitudinal compression seal joint between Span 8 & Br. 00571C, is not properly seated (lifted upwards) up to 2" inches high for 8' long.  Longitudinal strip seal joint in span 6 (Northbound) was not replaced and was mostly filled with sand and debris during this inspection. 20' of missing seal noted in the previous inspection report was not visible due to sand and debris accumulation. There is evidence of leakage at the underside of the joint.  West sidewalk joints at Piers 8-11 and at the North abutment are typically filled with sand. Pier 11 strip seal joint is missing a 1' long section of the gland. The aluminum hold down panel at Pier 9 joint is vertically misaligned up to 1" at one end due to broken/failed anchorages (potential tripping hazard).  See sheets 56-61 and Photos 41-48.

- Furnish and install new navigation lights transformer junction box (18" x 18" x 10", NEMA 3R cast iron with gasketed cover) with new transformer.
- Provide proper support for messenger-cable mounted high-tension feeders on the underside of the bridge.

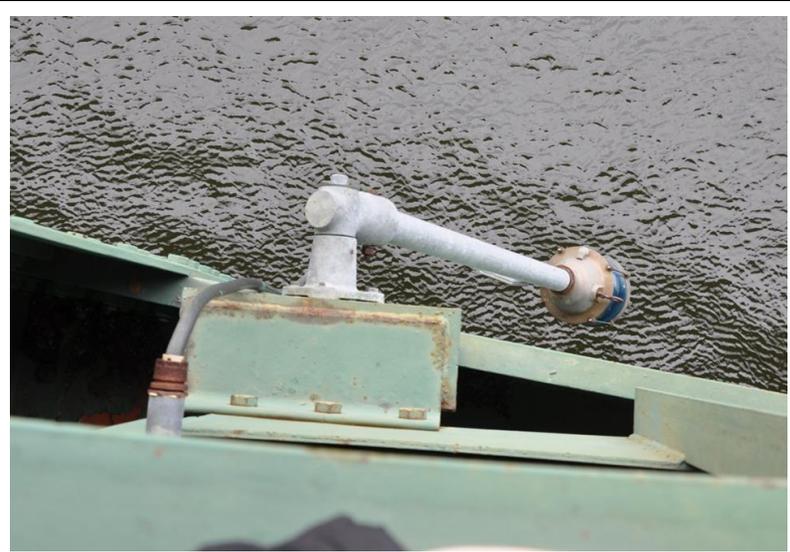
**Photo 40: Bridge No. 00571A, Navigation Lights.**

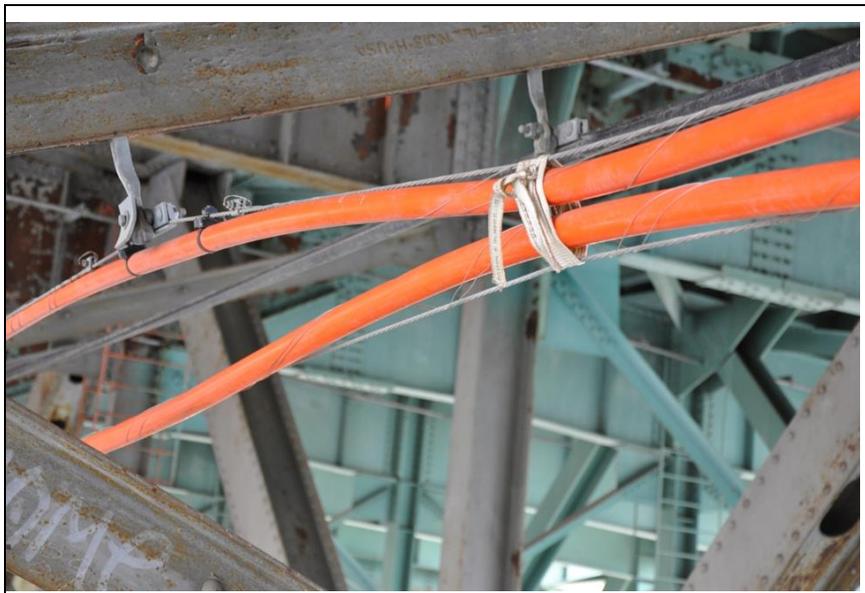
**Photo 41: Bridge No. 00571A, High-tension electrical cables routed under Bridge.**

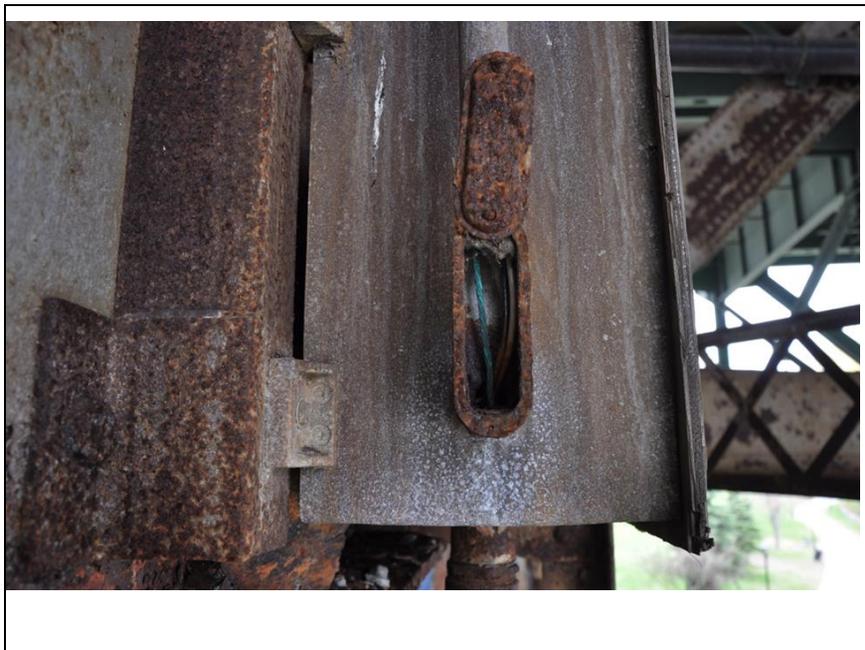
**Photo 43: Bridge No. 00571A, Junction Box.**
