STRUCTURE NO. 01061

ROUTE 67
over
LITTLE RIVER
SEYMOUR

Above & Underwater Inspection
on
10/23/06

BRIDGE NO. 01061
ROUTE 67 OVER LITTLE RIVER
SEYMOUR, CONNECTICUT
OCTOBER 23, 2006

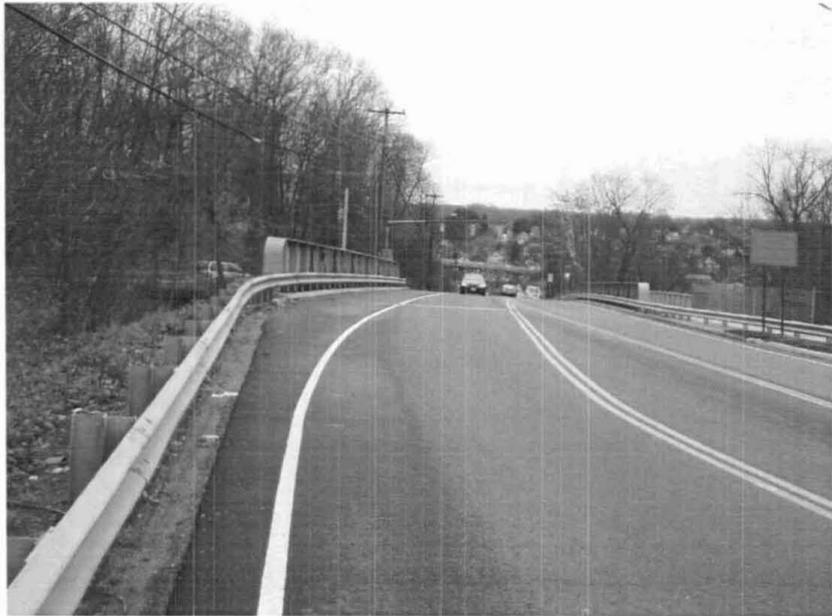
Photo #3:
Description: Bridge from the west approach.

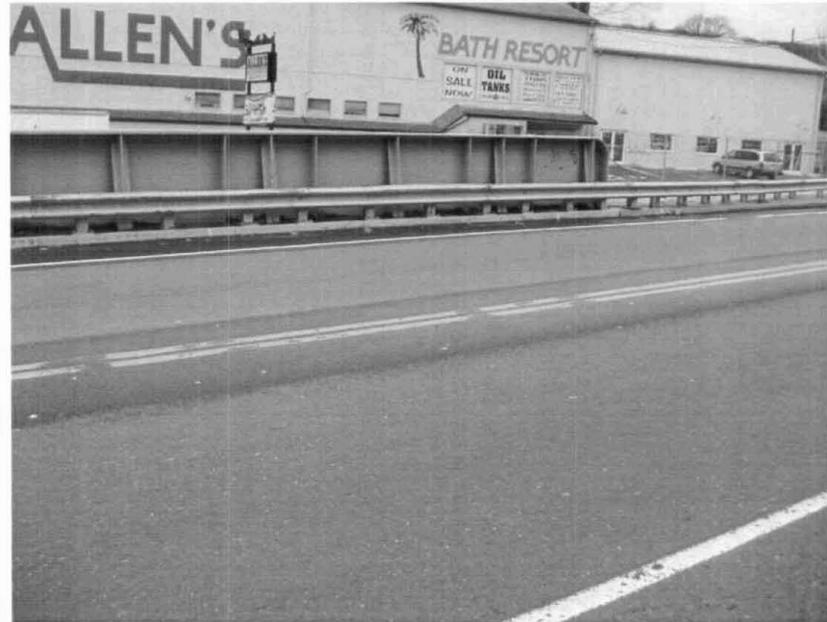
Photo #6:
Description: Typical top of deck.

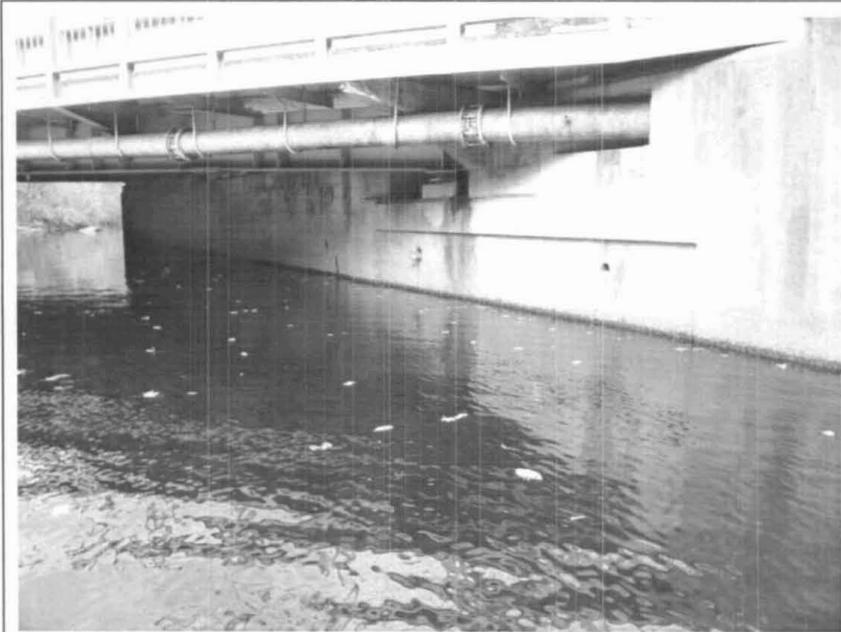
Photo #25:
Description: East abutment, typical.

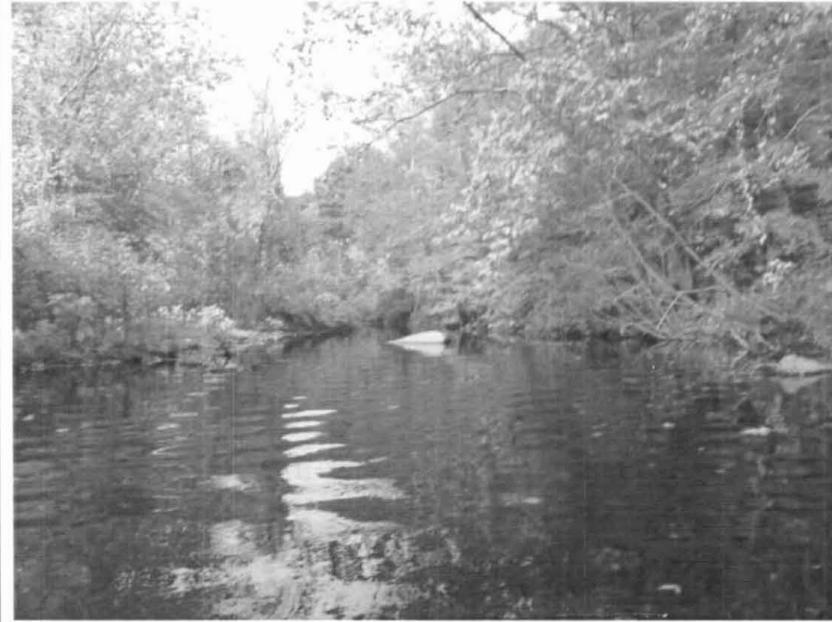
Photo #28:
Description: Channel, looking upstream.

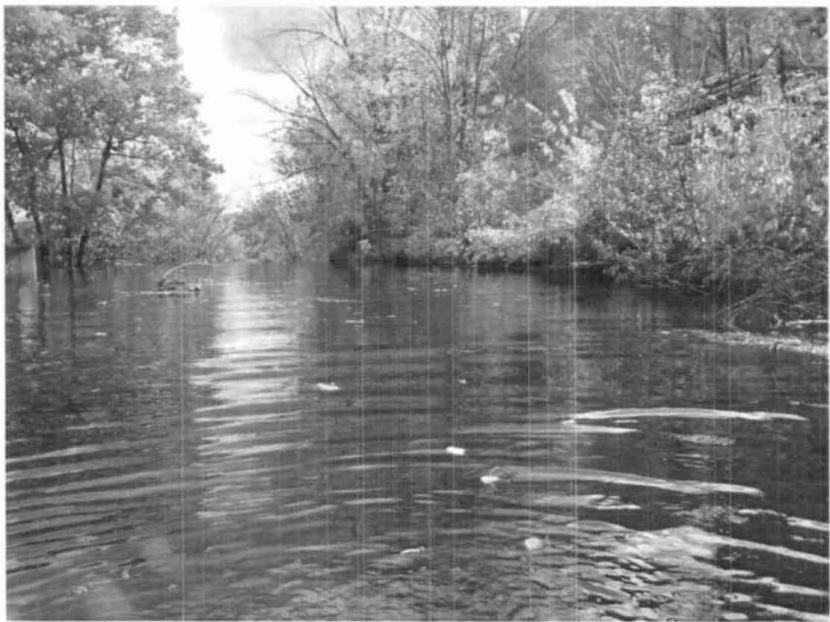
Photo #29:
Description: Channel, looking downstream.
